# Access Compliance Report

## Public Rights-of-Way

### (Curb Ramps)

| Intersection ID: 8573 | Main Street: N_GRAHAM_ST | Cross Street: ATANDO_AV | Location: NE |

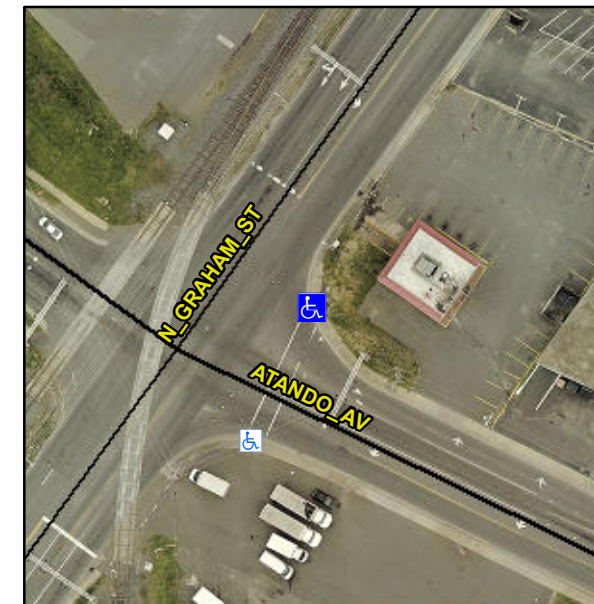
**RT RP < 5%**

**Not Found, R304.2.1, R304.2.2-Perp,  
R304.3.2-Para**

| Compliance | Description | Data | Compliance | Description | Data |
|---|---|---|---|---|---|
| No | Landing Width (in) | 43.0 | Yes | DWS Contrast? | Yes |
| No | Landing Slope (%) | 2.3 | Yes | DWS Length (in) | 25.0 |
| | | | Replace | Curb Slope (%) | 29.1 |

**Remove & Replace Entire Ramp.**
