# Access Compliance Report

## Public Rights-of-Way

### (Curb Ramps)

Intersection ID: 20847	Main Street: LANESBORO_RD	Cross Street: OLD_REID_RD	Location: N
ADA ID: 2A3A9B3ADAA3	Ramp Type: PerpDiag	Initial Pass/Fail: Fail	Overall Compliance: No
			Severity Score: 21.25

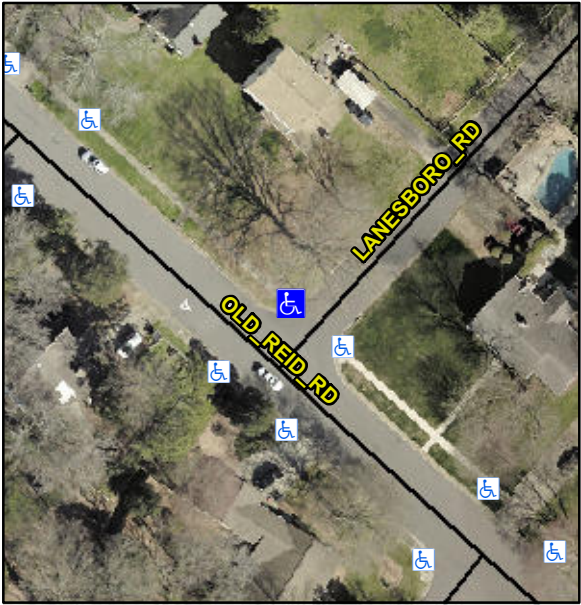
Possible Solutions:		<b>Compliance</b>	<b>Description</b>	<b>Data</b>
	<b>Remove &amp; Replace Curb Ramp With Two New Directional Ramps or Equivalent.</b>		<b>No</b>	Ramp Length (in)	24.0
			<b>No</b>	Ramp Width (in)	47.5
			<b>N/A</b>	Flare Type LT	N/A
			<b>N/A</b>	Flare Slope LT (%)	N/A
			<b>N/A</b>	Flare Traversable LT?	N/A
			<b>N/A</b>	Landing Length (in)	N/A
			<b>N/A</b>	Landing Width (in)	N/A
			<b>N/A</b>	Landing Slope (%)	N/A
			<b>N/A</b>	Landing X Slope (%)	N/A
<p>Surveyor Notes:</p> <p><b>N/A</b></p> <p>PROW/ADA:</p> <p><b>Not Found, R304.5.1, R304.2.2</b></p>			<b>N/A</b>	Flare Type RT	N/A
			<b>N/A</b>	Flare Slope RT (%)	N/A
			<b>N/A</b>	Flare Traversable RT?	N/A
			<b>N/A</b>	DWS Provided?	N/A
			<b>N/A</b>	DWS Contrast?	N/A
			<b>N/A</b>	DWS Length (in)	N/A
			<b>N/A</b>	DWS Full Width?	N/A
			<b>N/A</b>	DWS Offset (in)	N/A

<b>N/A</b>	Shared Landing?	N/A
			<b>N/A</b>	Gutter Ponding?	N/A
			<b>N/A</b>	Gutter Lip Ht (in)	N/A
			<b>N/A</b>	Painted X Walk1?	No
				X Walk 1 Direction	To SW
			<b>N/A</b>	X Walk 1 Width (in)	N/A
				X Walk 1 Slope (%)	3.5
				X Walk 1 X Slope (%)	0.2
			<b>N/A</b>	Ramp inside XWalk1?	N/A
				Road Slope (%)	1.9
				Road X Slope (%)	3.9
			<b>N/A</b>	Any Obstructions?	N/A
Total Cost:		\$ 3200.00		Obstruction Type	
			<b>N/A</b>		N/A
			<b>Yes</b>	Surface Condition? (G/P)	Good
