Intersection ID: 16920	Main Street: IDLEWILD_RD	Cross Street: CEDARWILD_RD	Location:	S
ADA ID: 2A3FD26AE7D2	Ramp Type: PerpDiag	Initial Pass/Fail: Fail	Overall Compliance: No	Severity Score: 25

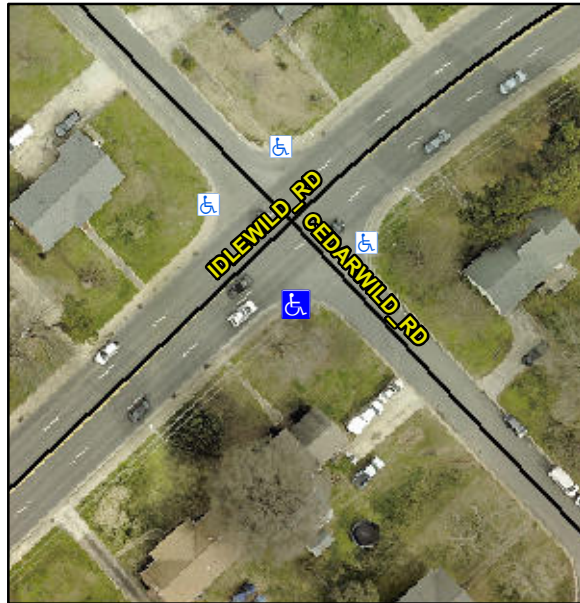
Not Found, R304.2.2, R304.5.3

Compliance	Description	Data	Compliance	Description	Data
N/A	Ramp Length (in)	60.0	No	Ramp Slope (%)	10.0
Yes	Ramp Width (in)	48.0	No	Ramp XSlope (%)	6.0
N/A	Flare Type LT	N/A	N/A	Flare Type RT	N/A
N/A	Flare Slope LT (%)	N/A	N/A	Flare Slope RT (%)	N/A
N/A	Flare Traversable LT?	N/A	N/A	Flare Traversable RT?	N/A
N/A	Landing Length (in)	N/A	N/A	DWS Provided?	N/A
N/A	Landing Width (in)	N/A	N/A	DWS Contrast?	N/A
N/A	Landing Slope (%)	N/A	N/A	DWS Length (in)	N/A
N/A	Landing X Slope (%)	N/A	N/A	DWS Full Width?	N/A
N/A	Landing Curb? (Y/N)	N/A	N/A	DWS Offset (in)	N/A
N/A	Shared Landing?	N/A			
N/A	Gutter Ponding?	N/A	N/A	Gutter Slope (%)	N/A
N/A	Gutter Lip Ht (in)	N/A	N/A	Gutter X Slope (%)	N/A
N/A	Painted X Walk1?	No	N/A	Painted X Walk2?	No
	X Walk 1 Direction	To NE		X Walk 2 Direction	To NW
N/A	X Walk 1 Width (in)	N/A	N/A	X Walk 2 Width (in)	N/A
	X Walk 1 Slope (%)	0.4		X Walk 2 Slope (%)	5.0
	X Walk 1 X Slope (%)	5.6		X Walk 2 X Slope (%)	1.6

N/A	Ramp inside XWalk1?	N/A	N/A	Ramp inside XWalk2?	N/A
	Road Slope (%)	5.0	N/A	Clear Space?	N/A
	Road X Slope (%)	4.1	N/A	Clear Space to XWalk (in)	N/A
N/A	Any Obstructions?	N/A	N/A	Storm Grate/Utility Hazard?	N/A
	Obstruction Type			Storm Grate/Utility Type	
		N/A			N/A
			Yes	Surface Condition? (G/P)	Good

Remove & Replace Curb Ramp With Two New Directional Ramps or Equivalent.

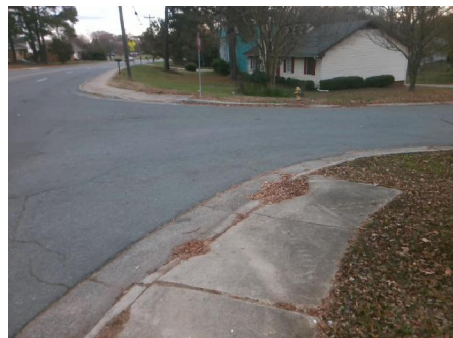
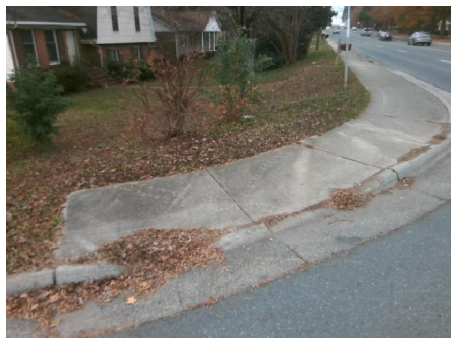
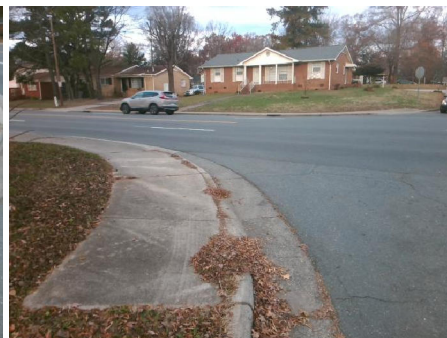
Street 1 Name	CEDARWILD RD
Stop Condition-Street 2	StopSign
Street 2 Name	IDLEWILD RD
Stop Condition-Street 1	None
