Access Compliance Report

Public Rights-of-Way

(Curb Ramps)

| Intersection ID: 53253 | Main Street: MARLOWE_AV | Cross Street: ALYSSA_LN | Location: SW |

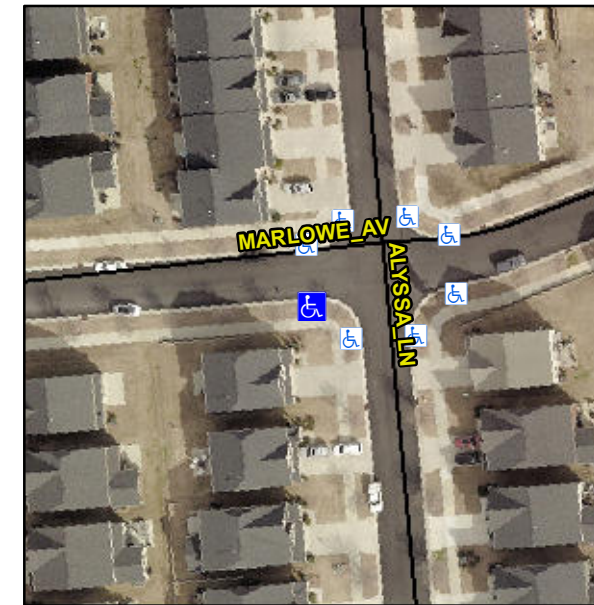
| ADA ID: 2A4B75226EB9 | Ramp Type: Perp | Initial Pass/Fail: Fail | Overall Compliance: No |

Not Found, R304.5.1

| Compliance | Description | Data | Compliance | Description | Data |
|---|---|---|---|---|---|
| N/A | Ramp Length (in) | 97.0 | Yes | Ramp Slope (%) | 6.5 |
| No | Ramp Width (in) | 47.0 | Yes | Ramp XSlope (%) | 1.3 |

Remove & Replace Entire Ramp.

Total Cost: \$ 1850.00
