Access Compliance Report

Public Rights-of-Way

(Curb Ramps)

Intersection ID: 16141	Main Street: N_WENDOVER_RD	Cross Street: LATROBE_DR	Location: SW
ADA ID: 2A4DEA06C405	Ramp Type: Perp	Initial Pass/Fail: Fail	Overall Compliance: No
Severity Score: 22.5			
Codes/Mitigation Info/Possible Solution		Field Measurements/Component Compliance

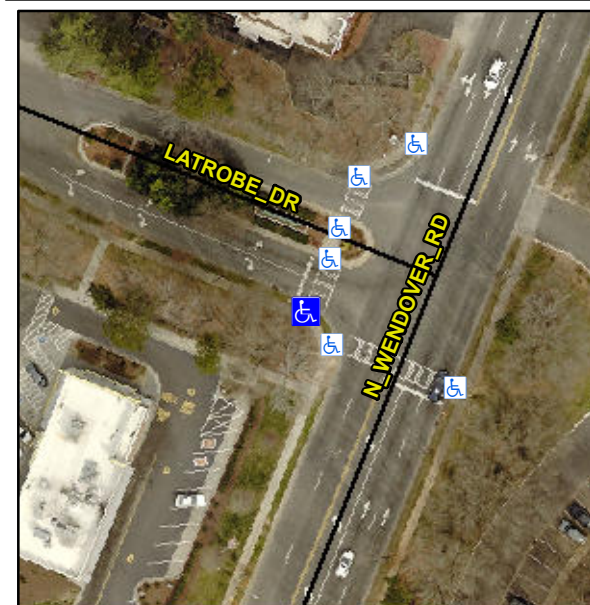
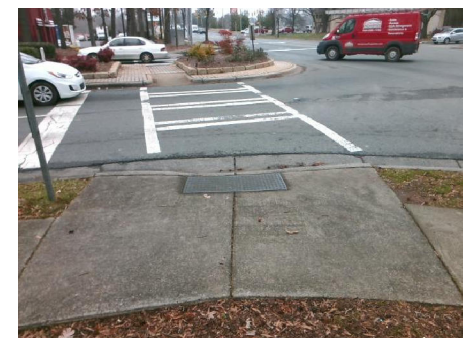
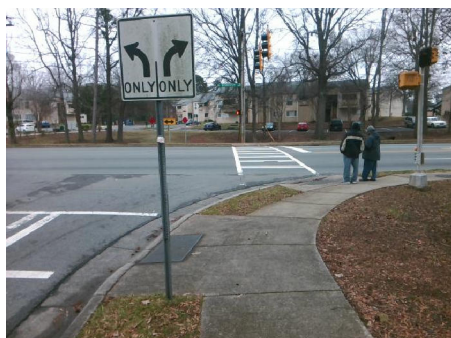
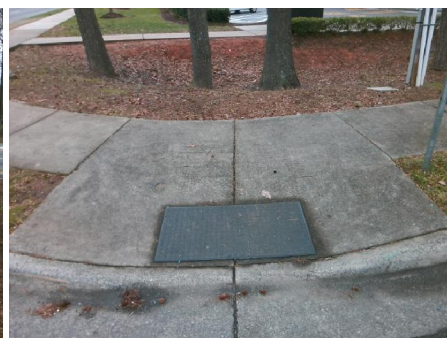
Not Found, R304.5.1, R304.2.2

Compliance	Description	Data	Compliance	Description	Data
N/A	Ramp Length (in)	52.0	No	Ramp Slope (%)	10.1
No	Ramp Width (in)	42.0	Yes	Ramp XSlope (%)	2.6
N/A	Flare Type LT	N/A	N/A	Flare Type RT	N/A
N/A	Flare Slope LT (%)	N/A	N/A	Flare Slope RT (%)	N/A
N/A	Flare Traversable LT?	N/A	N/A	Flare Traversable RT?	N/A
N/A	Landing Length (in)	N/A	N/A	DWS Provided?	N/A
N/A	Landing Width (in)	N/A	N/A	DWS Contrast?	N/A
N/A	Landing Slope (%)	N/A	N/A	DWS Length (in)	N/A
N/A	Landing X Slope (%)	N/A	N/A	DWS Full Width?	N/A
N/A	Landing Curb? (Y/N)	N/A	N/A	DWS Offset (in)	N/A
N/A	Shared Landing?	N/A			
N/A	Gutter Ponding?	N/A	N/A	Gutter Slope (%)	N/A
N/A	Gutter Lip Ht (in)	N/A	N/A	Gutter X Slope (%)	N/A
N/A	Painted X Walk1?	Yes	N/A	Painted X Walk2?	N/A
	X Walk 1 Direction	To NE		X Walk 2 Direction	N/A
N/A	X Walk 1 Width (in)	111.0	N/A	X Walk 2 Width (in)	N/A
	X Walk 1 Slope (%)	9.8		X Walk 2 Slope (%)	N/A
	X Walk 1 X Slope (%)	3.1		X Walk 2 X Slope (%)	N/A

N/A	Ramp inside XWalk1?	Yes	N/A	Ramp inside XWalk2?	N/A
	Road Slope (%)	N/A	N/A	Clear Space?	N/A
	Road X Slope (%)	N/A	N/A	Clear Space to XWalk (in)	N/A
N/A	Any Obstructions?	N/A	N/A	Storm Grate/Utility Hazard?	N/A
	Obstruction Type			Storm Grate/Utility Type	
		N/A			N/A
		Yes		Surface Condition? (G/P)	Good

Possible Solutions:

Remove & Replace Entire Ramp.
