Access Compliance Report Public Rights-of-Way (Curb Ramps)

Intersection ID: 52442 Main Street: WOODWARD AV Cross Street: BENDING_BIRCH_PL Location: SW ADA ID: 2A53B93C1663 Ramp Type: Directional1 Initial Pass/Fail: Fail **Overall Compliance: No Severity Score:** 12.5

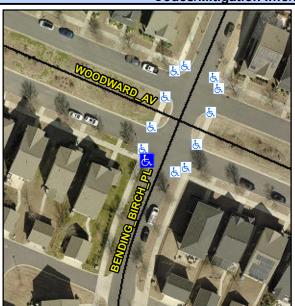
Field Measurements/Component Compliance						
Compliance Description		Data	Compliance Description		Data	
N/A	Ramp Length (in)	68.0	N/A	Grade Break?	N/A	
Yes	Ramp Width (in)	60.5	N/A	Grade Break Slope (%)	0.0	
No	Ramp Slope (%)	9.8	N/A	Grade Break XSlope (%)	0.0	
Yes	Ramp XSlope (%)	0.2				
N/A	Flare Type LT	N/A	N/A	Flare Type RT	N/A	
N/A	Flare Slope LT (%)	N/A	N/A	Flare Slope RT (%)	0.0	
N/A	Flare Traversable LT?	N/A	N/A	Flare Traversable RT?	N/A	
N/A	Landing Length (in)	0.0	N/A	DWS Provided?	N/A	
N/A	Landing Width (in)	0.0	N/A	DWS Contrast?	N/A	
N/A	Landing Slope (%)	0.0	N/A	DWS Length (in)	N/A	
N/A	Landing X Slope (%)	0.0	N/A	DWS Full Width?	N/A	
N/A	Landing Curb? (Y/N)	N/A	N/A	DWS Offset LT (in)	N/A	
N/A	Shared Landing?	N/A	N/A	DWS Offset RT (in)	N/A	
N/A	Gutter Ponding?	0.0	N/A	Gutter Slope (%)	N/A	
N/A	Gutter Lip Ht (in)	1.5	N/A	Gutter X Slope (%)	N/A	
N/A	Painted X Walk1?	No		Road Slope (%)	2.9	
	X Walk 1 Direction	To E		Road X Slope (%)	1.6

FOSSIDIE SOIULIOII	
Possible Solutions:	9
Remove & Replace Entire Ramp.	ľ
·	١
	ı
	١
	1
	1
Surveyor Notes:	1
N/A	1
	ı
	1
	1
PROW/ADA:	1
R304.2.2	1
	1
	ı
	1

Total Cost: 1600.00
