# Access Compliance Report

## Public Rights-of-Way

### (Curb Ramps)

Intersection ID: 48985	Main Street: AVONCLIFF_DR	Cross Street: KINGSDOWN_AV	Location: NE
ADA ID: 2A5BDB0BF1F3	Ramp Type: Perp	Initial Pass/Fail: Fail	Overall Compliance: No
Severity Score: 37.5			
Codes/Mitigation Info/Possible Solution		Field Measurements/Component Compliance

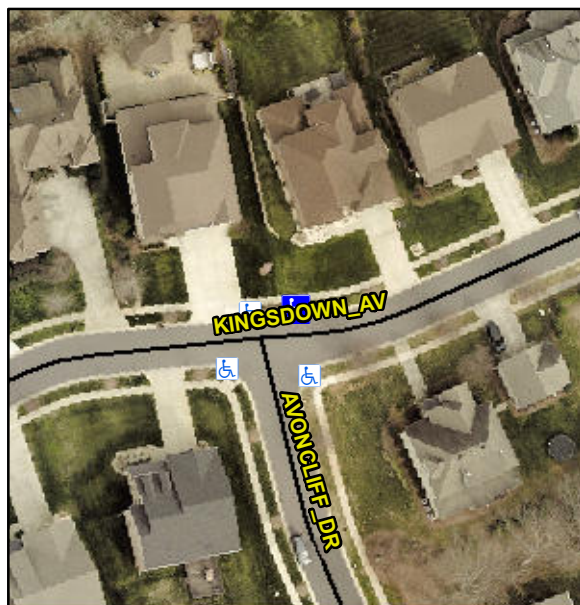
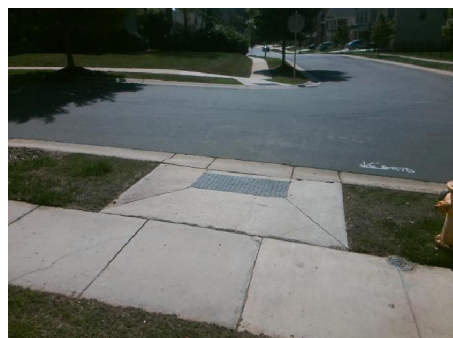
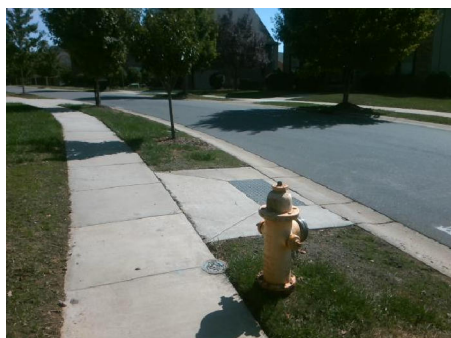
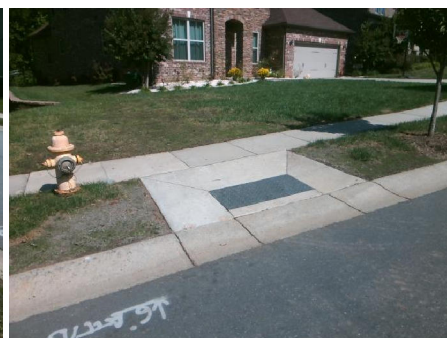
**Not Found, R304.2.2, R304.5.3**

Compliance	Description	Data	Compliance	Description	Data
N/A	Ramp Length (in)	69.0	No	Ramp Slope (%)	8.7
Yes	Ramp Width (in)	48.0	No	Ramp XSlope (%)	7.0
N/A	Flare Type LT	N/A	N/A	Flare Type RT	N/A
N/A	Flare Slope LT (%)	N/A	N/A	Flare Slope RT (%)	N/A
N/A	Flare Traversable LT?	N/A	N/A	Flare Traversable RT?	N/A
N/A	Landing Length (in)	N/A	N/A	DWS Provided?	N/A
N/A	Landing Width (in)	N/A	N/A	DWS Contrast?	N/A
N/A	Landing Slope (%)	N/A	N/A	DWS Length (in)	N/A
N/A	Landing X Slope (%)	N/A	N/A	DWS Full Width?	N/A
N/A	Landing Curb? (Y/N)	N/A	N/A	DWS Offset (in)	N/A
N/A	Shared Landing?	N/A			
N/A	Gutter Ponding?	N/A	N/A	Gutter Slope (%)	N/A
N/A	Gutter Lip Ht (in)	N/A	N/A	Gutter X Slope (%)	N/A
N/A	Painted X Walk1?	No	N/A	Painted X Walk2?	N/A
	X Walk 1 Direction	To S		X Walk 2 Direction	N/A
N/A	X Walk 1 Width (in)	N/A	N/A	X Walk 2 Width (in)	N/A
	X Walk 1 Slope (%)	2.7		X Walk 2 Slope (%)	N/A
	X Walk 1 X Slope (%)	6.0		X Walk 2 X Slope (%)	N/A

N/A	Ramp inside XWalk1?	N/A	N/A	Ramp inside XWalk2?	N/A
	Road Slope (%)	N/A	N/A	Clear Space?	N/A
	Road X Slope (%)	N/A	N/A	Clear Space to XWalk (in)	N/A
N/A	Any Obstructions?	N/A	N/A	Storm Grate/Utility Hazard?	N/A
	Obstruction Type			Storm Grate/Utility Type	
		N/A			N/A
			Yes	Surface Condition? (G/P)	Good

**Remove & Replace Entire Ramp.**
