# Access Compliance Report

## Public Rights-of-Way

### (Curb Ramps)

Intersection ID: 3365	Main Street: CRAYTON_DR	Cross Street: FAIRLEA_DR	Location: SE
ADA ID: 2A66B7CFA5C5	Ramp Type: BlendTrans1	Initial Pass/Fail: Fail	Overall Compliance: No
		Severity Score: 12.5

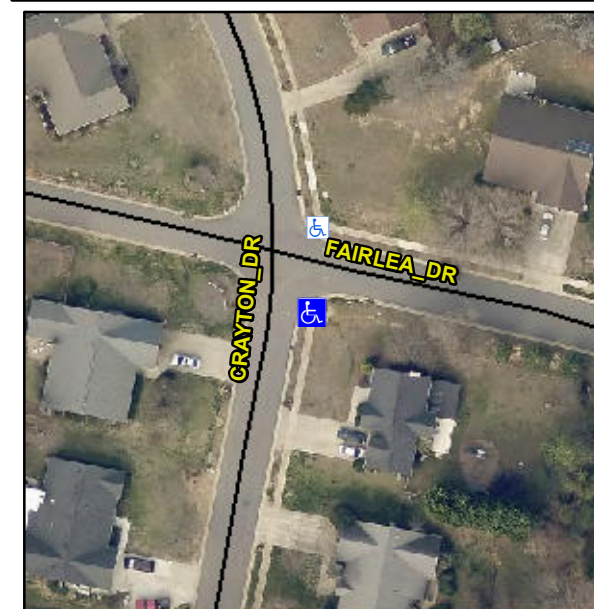
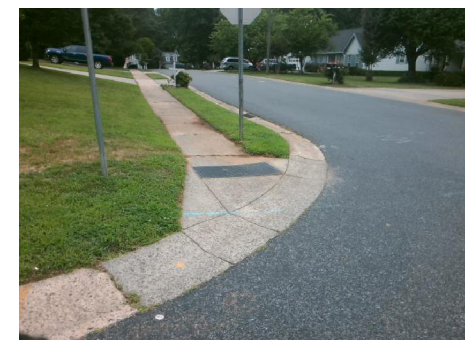
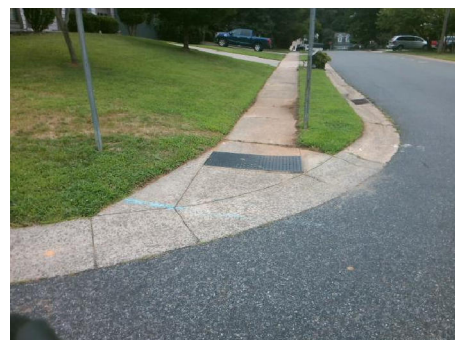
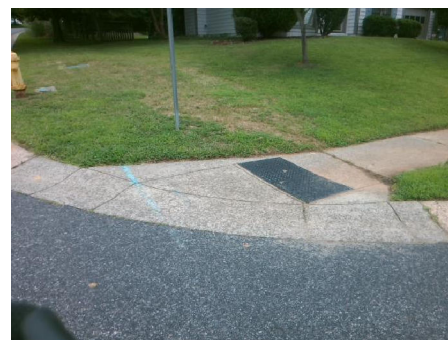
**Not Found, R304.5.3**

Compliance	Description	Data	Compliance	Description	Data
N/A	Ramp Length (in)	51.0	Yes	BlendTrans Slope (%)	2.3
Yes	Ramp Width (in)	48.0	No	BlendTrans XSlope (%)	6.5
N/A	Flare Type LT	N/A	N/A	Flare Type RT	N/A
N/A	Flare Slope LT (%)	N/A	N/A	Flare Slope RT (%)	N/A
N/A	Flare Traversable LT?	N/A	N/A	Flare Traversable RT?	N/A
N/A	Landing Length (in)	N/A	N/A	DWS Provided?	N/A
N/A	Landing Width (in)	N/A	N/A	DWS Contrast?	N/A
N/A	Landing Slope (%)	N/A	N/A	DWS Length (in)	N/A
N/A	Landing X Slope (%)	N/A	N/A	DWS Full Width?	N/A
N/A	Landing Curb? (Y/N)	N/A	N/A	DWS Offset (in)	N/A
N/A	Shared Landing?	N/A			
N/A	Gutter Ponding?	N/A	N/A	Gutter Slope (%)	N/A
N/A	Gutter Lip Ht (in)	N/A	N/A	Gutter X Slope (%)	N/A
N/A	Painted X Walk1?	No	N/A	Painted X Walk2?	N/A
	X Walk 1 Direction	To N		X Walk 2 Direction	N/A
	X Walk 1 Width (in)	N/A		X Walk 2 Width (in)	N/A
	X Walk 1 Slope (%)	3.4		X Walk 2 Slope (%)	N/A
	X Walk 1 X Slope (%)	1.6		X Walk 2 X Slope (%)	N/A

N/A	Ramp inside XWalk1?	N/A	N/A	Ramp inside XWalk2?	N/A
	Road Slope (%)	1.6		Clear Space?	N/A
	Road X Slope (%)	3.4	N/A	Clear Space to XWalk (in)	N/A
N/A	Any Obstructions?	N/A	N/A	Storm Grate/Utility Hazard?	N/A
	Obstruction Type			Storm Grate/Utility Type	
		N/A			N/A
			Yes	Surface Condition? (G/P)	Good
			No	Curb Slope (%)	6.8

**Remove & Replace Curb Ramp With Two New Directional Ramps or Equivalent.**

Total Cost: \$ 3200.00
