# Access Compliance Report

## Public Rights-of-Way

### (Curb Ramps)

Intersection ID: 11783	Main Street: N_GRAHAM_ST	Cross Street: W_5TH_ST	Location: S
ADA ID: 2A673130FF49	Ramp Type: Perp	Initial Pass/Fail: Fail	Overall Compliance: No
			Severity Score: 13.75

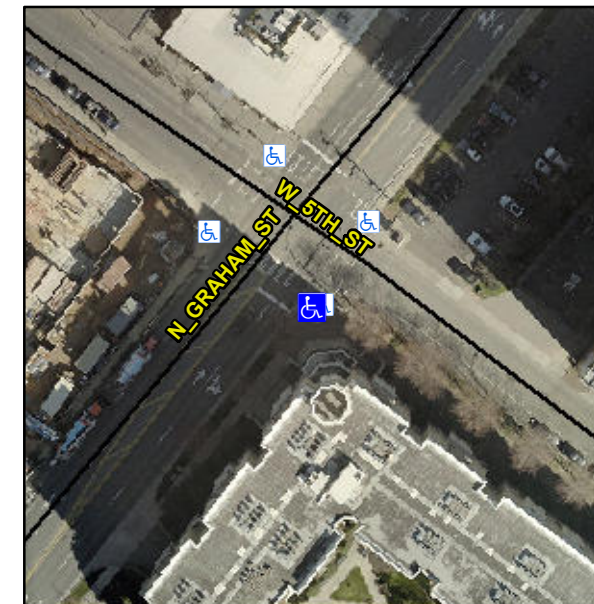
**R304.2.2, R304.5.3**

Compliance	Description	Data	Compliance	Description	Data
N/A	Ramp Length (in)	88.0	No	Ramp Slope (%)	8.8
Yes	Ramp Width (in)	53.0	No	Ramp XSlope (%)	2.6
N/A	Flare Type LT	N/A	N/A	Flare Type RT	N/A
N/A	Flare Slope LT (%)	N/A	N/A	Flare Slope RT (%)	N/A
N/A	Flare Traversable LT?	N/A	N/A	Flare Traversable RT?	N/A
N/A	Landing Length (in)	N/A	N/A	DWS Provided?	N/A
N/A	Landing Width (in)	N/A	N/A	DWS Contrast?	N/A
N/A	Landing Slope (%)	N/A	N/A	DWS Length (in)	N/A
N/A	Landing X Slope (%)	N/A	N/A	DWS Full Width?	N/A
N/A	Landing Curb? (Y/N)	N/A	N/A	DWS Offset (in)	N/A
N/A	Shared Landing?	N/A			
N/A	Gutter Ponding?	N/A	N/A	Gutter Slope (%)	N/A
N/A	Gutter Lip Ht (in)	N/A	N/A	Gutter X Slope (%)	N/A
N/A	Painted X Walk1?	Yes	N/A	Painted X Walk2?	N/A
	X Walk 1 Direction	To NW		X Walk 2 Direction	N/A
N/A	X Walk 1 Width (in)	100.0	N/A	X Walk 2 Width (in)	N/A
	X Walk 1 Slope (%)	1.7		X Walk 2 Slope (%)	N/A
	X Walk 1 X Slope (%)	1.7		X Walk 2 X Slope (%)	N/A

N/A	Ramp inside XWalk1?	Yes	N/A	Ramp inside XWalk2?	N/A
	Road Slope (%)	N/A	N/A	Clear Space?	N/A
	Road X Slope (%)	N/A	N/A	Clear Space to XWalk (in)	N/A
N/A	Any Obstructions?	N/A	N/A	Storm Grate/Utility Hazard?	N/A
	Obstruction Type			Storm Grate/Utility Type	
		N/A			N/A
			Yes	Surface Condition? (G/P)	Good

**Remove & Replace Entire Ramp.**

Total Cost: \$ 1850.00
