Access Compliance Report

Public Rights-of-Way

(Curb Ramps)

Intersection ID: 11686	Main Street: BRISTOL_DR	Cross Street: CARLYLE_DR	Location: SW
ADA ID: 2A685B32BF48	Ramp Type: BlendTrans2	Initial Pass/Fail: Fail	Overall Compliance: No
		Severity Score: 10

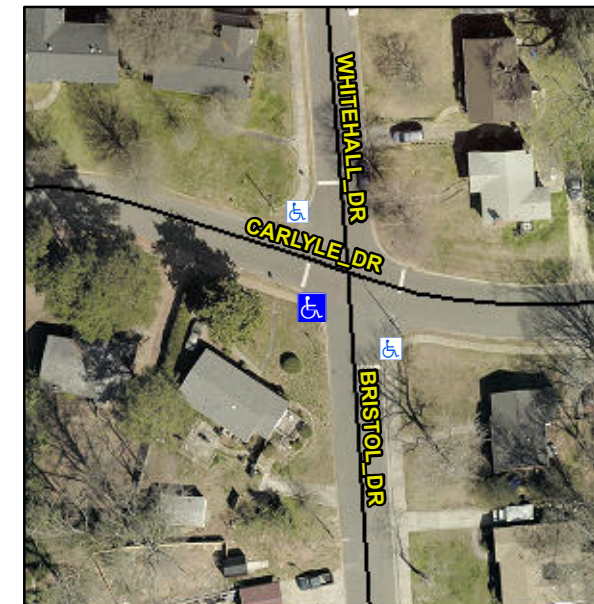
NO LT SW

Not Found, R304.5.1, R304.5.3

Compliance	Description	Data	Compliance	Description	Data
N/A	Ramp Length (in)	57.5	Yes	BlendTrans Slope (%)	3.9
No	Ramp Width (in)	41.0	No	BlendTrans XSlope (%)	2.6
N/A	Flare Type LT	N/A	N/A	Flare Type RT	N/A
N/A	Flare Slope LT (%)	N/A	N/A	Flare Slope RT (%)	N/A
N/A	Flare Traversable LT?	N/A	N/A	Flare Traversable RT?	N/A
N/A	Landing Length (in)	N/A	N/A	DWS Provided?	N/A
N/A	Landing Width (in)	N/A	N/A	DWS Contrast?	N/A
N/A	Landing Slope (%)	N/A	N/A	DWS Length (in)	N/A
N/A	Landing X Slope (%)	N/A	N/A	DWS Full Width?	N/A
N/A	Landing Curb? (Y/N)	N/A	N/A	DWS Offset (in)	N/A
N/A	Shared Landing?	N/A			
N/A	Gutter Ponding?	N/A	N/A	Gutter Slope (%)	N/A
N/A	Gutter Lip Ht (in)	N/A	N/A	Gutter X Slope (%)	N/A
N/A	Painted X Walk1?	No	N/A	Painted X Walk2?	No
	X Walk 1 Direction	To SE		X Walk 2 Direction	To N
	X Walk 1 Width (in)	N/A		X Walk 2 Width (in)	N/A
	X Walk 1 Slope (%)	0.5		X Walk 2 Slope (%)	3.9
	X Walk 1 X Slope (%)	4.3		X Walk 2 X Slope (%)	0.6

N/A	Ramp inside XWalk1?	N/A	N/A	Ramp inside XWalk2?	N/A
	Road Slope (%)	2.7		Clear Space?	N/A
	Road X Slope (%)	4.6	N/A	Clear Space to XWalk (in)	N/A
N/A	Any Obstructions?	N/A	N/A	Storm Grate/Utility Hazard?	N/A
	Obstruction Type			Storm Grate/Utility Type	
		N/A			N/A
			Yes	Surface Condition? (G/P)	Good
			No	Curb Slope (%)	28.2

Possible Solutions:

Remove & Replace Curb Ramp With Two New Directional Ramps or Equivalent.
