Access Compliance Report Public Rights-of-Way (Curb Ramps)

Intersection ID: 50320 Main Street: BRYN_ATHYN_CT Cross Street: CINDY_LN Location: NW

ADA ID: 2A6C885F9F10 Ramp Type: Directional1 Initial Pass/Fail: Fail Overall Compliance: No Severity Score: 12.5

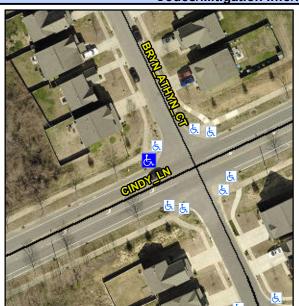
| Possible Solution Fleid Measurements/Component Comp | | | | | | | nent Compliance | |
|---|---|---|---|---|---|---|---|--|
| | | | No | Ramp Slope (%) | 9.2 | N/A | Grade Break XSlope (%) | |

| Possible Solution Fleid Measurements/Component Comp | | | | | | | nent Compliance | |
|---|---|---|---|---|---|---|---|--|
| Remove & Replace Entire | Ram | ıp. | N/A | Ramp Length (in) | 85.0 | N/A | Grade Break? | |
| R304.2.2 | | | N/A | Shared Landing? | N/A | N/A | DWS Offset RT (in) | |
| Total Cost: | \$ | 1600.00 | | Obstruction Type | | Yes | Surface Condition? (G/P) | |
