# Access Compliance Report

## Public Rights-of-Way

### (Curb Ramps)

Intersection ID: 17369	Main Street: DELANE_AV	Cross Street: N_SHARON_AMITY_RD	Location: SW
ADA ID: 2A7C5581B7E2	Ramp Type: PerpDiag	Initial Pass/Fail: Fail	Overall Compliance: No
			Severity Score: 21.25

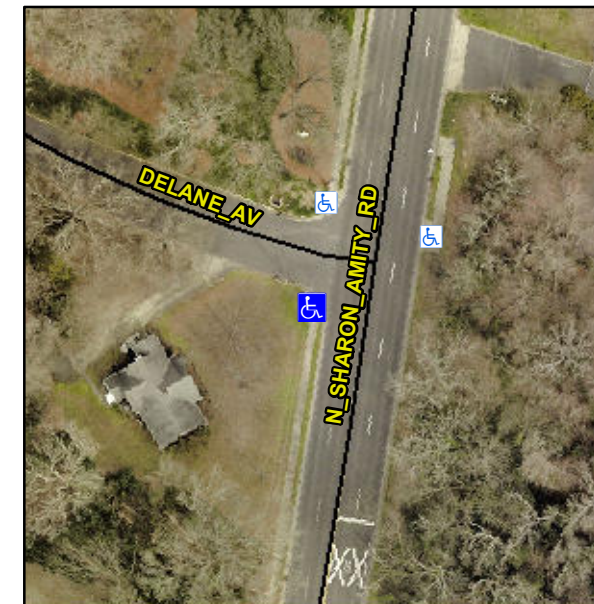
**Not Found, R304.5.1, R304.2.2**

Compliance	Description	Data	Compliance	Description	Data
N/A	Ramp Length (in)	39.0	No	Ramp Slope (%)	8.7
No	Ramp Width (in)	43.0	Yes	Ramp XSlope (%)	1.7
N/A	Flare Type LT	N/A	N/A	Flare Type RT	N/A
N/A	Flare Slope LT (%)	N/A	N/A	Flare Slope RT (%)	N/A
N/A	Flare Traversable LT?	N/A	N/A	Flare Traversable RT?	N/A
N/A	Landing Length (in)	N/A	N/A	DWS Provided?	N/A
N/A	Landing Width (in)	N/A	N/A	DWS Contrast?	N/A
N/A	Landing Slope (%)	N/A	N/A	DWS Length (in)	N/A
N/A	Landing X Slope (%)	N/A	N/A	DWS Full Width?	N/A
N/A	Landing Curb? (Y/N)	N/A	N/A	DWS Offset (in)	N/A
N/A	Shared Landing?	N/A			
N/A	Gutter Ponding?	N/A	N/A	Gutter Slope (%)	N/A
N/A	Gutter Lip Ht (in)	N/A	N/A	Gutter X Slope (%)	N/A
N/A	Painted X Walk1?	No	N/A	Painted X Walk2?	No
	X Walk 1 Direction	To SE		X Walk 2 Direction	To NE
N/A	X Walk 1 Width (in)	N/A	N/A	X Walk 2 Width (in)	N/A
	X Walk 1 Slope (%)	6.4		X Walk 2 Slope (%)	0.5
	X Walk 1 X Slope (%)	0.9		X Walk 2 X Slope (%)	4.7

N/A	Ramp inside XWalk1?	N/A	N/A	Ramp inside XWalk2?	N/A
	Road Slope (%)	3.1	N/A	Clear Space?	N/A
	Road X Slope (%)	6.8	N/A	Clear Space to XWalk (in)	N/A
N/A	Any Obstructions?	N/A	N/A	Storm Grate/Utility Hazard?	N/A
	Obstruction Type			Storm Grate/Utility Type	
		N/A			N/A
			Yes	Surface Condition? (G/P)	Good

**Remove & Replace Curb Ramp With Two New Directional Ramps or Equivalent.**

Total Cost: \$ 3200.00
