Access Compliance Report

Public Rights-of-Way

(Curb Ramps)

Intersection ID: 18339	Main Street: BEECHGROVE CT	Cross Street: MCLAUGHLIN DR	Location: W
ADA ID: 2A8E3FD1D1CD	Ramp Type: PerpDiag	Initial Pass/Fail: Fail	Overall Compliance: No
Severity Score: 21.25			
Codes/Mitigation Info/Possible Solution		Field Measurements/Component Compliance

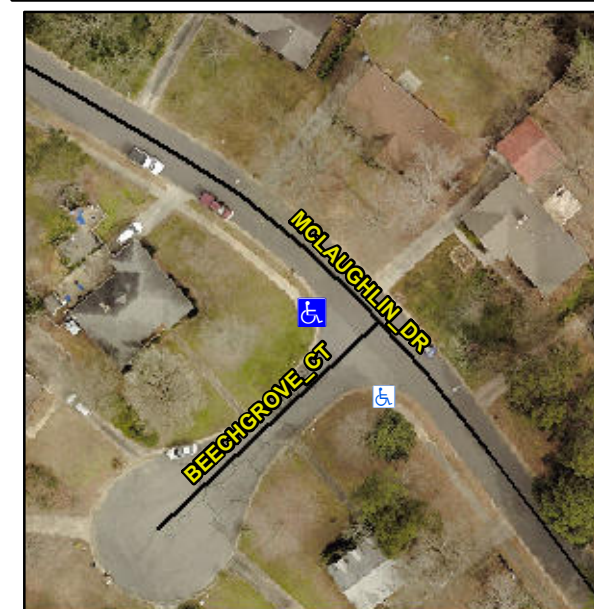
Not Found, R304.5.1, R304.2.2

Compliance	Description	Data	Compliance	Description	Data
N/A	Ramp Length (in)	48.0	No	Ramp Slope (%)	8.7
No	Ramp Width (in)	47.5	Yes	Ramp XSlope (%)	1.1
N/A	Flare Type LT	N/A	N/A	Flare Type RT	N/A
N/A	Flare Slope LT (%)	N/A	N/A	Flare Slope RT (%)	N/A
N/A	Flare Traversable LT?	N/A	N/A	Flare Traversable RT?	N/A
N/A	Landing Length (in)	N/A	N/A	DWS Provided?	N/A
N/A	Landing Width (in)	N/A	N/A	DWS Contrast?	N/A
N/A	Landing Slope (%)	N/A	N/A	DWS Length (in)	N/A
N/A	Landing X Slope (%)	N/A	N/A	DWS Full Width?	N/A
N/A	Landing Curb? (Y/N)	N/A	N/A	DWS Offset (in)	N/A
N/A	Shared Landing?	N/A			
N/A	Gutter Ponding?	N/A	N/A	Gutter Slope (%)	N/A
N/A	Gutter Lip Ht (in)	N/A	N/A	Gutter X Slope (%)	N/A
N/A	Painted X Walk1?	No	N/A	Painted X Walk2?	No
	X Walk 1 Direction	To SE		X Walk 2 Direction	To E
N/A	X Walk 1 Width (in)	N/A	N/A	X Walk 2 Width (in)	N/A
	X Walk 1 Slope (%)	0.8		X Walk 2 Slope (%)	3.9
	X Walk 1 X Slope (%)	2.5		X Walk 2 X Slope (%)	1.3

N/A	Ramp inside XWalk1?	N/A	N/A	Ramp inside XWalk2?	N/A
	Road Slope (%)	1.3	N/A	Clear Space?	N/A
	Road X Slope (%)	2.1	N/A	Clear Space to XWalk (in)	N/A
N/A	Any Obstructions?	N/A	N/A	Storm Grate/Utility Hazard?	N/A
	Obstruction Type			Storm Grate/Utility Type	
		N/A			N/A
		Yes		Surface Condition? (G/P)	Good

Remove & Replace Curb Ramp With Two New Directional Ramps or Equivalent.
