Intersection ID: N/A	Main Street: E_TRADE_ST	Cross Street: N/A	Location:	SE
ADA ID: 2A950A78B3C7	Ramp Type: Perp	Initial Pass/Fail: Fail	Overall Compliance: No	Severity Score: 21.25

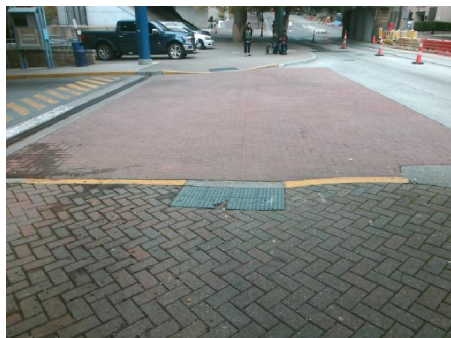
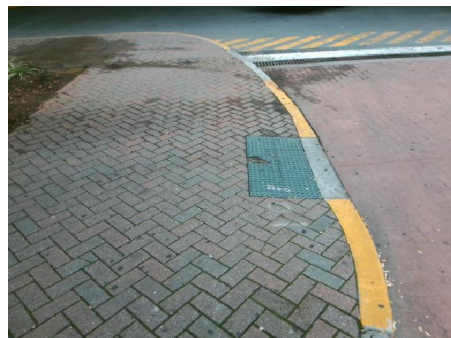
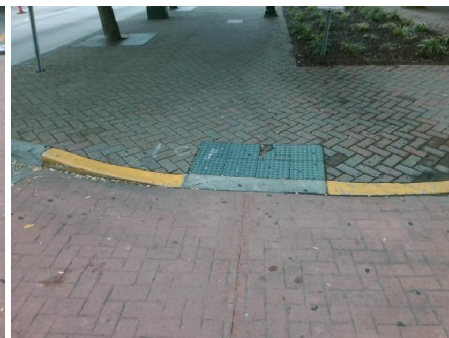
R304.5.1, R304.5.3

Compliance	Description	Data	Compliance	Description	Data
N/A	Ramp Length (in)	48.0	Yes	Ramp Slope (%)	5.9
No	Ramp Width (in)	47.0	No	Ramp XSlope (%)	6.2
N/A	Flare Type LT	N/A	N/A	Flare Type RT	N/A
N/A	Flare Slope LT (%)	N/A	N/A	Flare Slope RT (%)	N/A
N/A	Flare Traversable LT?	N/A	N/A	Flare Traversable RT?	N/A
N/A	Landing Length (in)	N/A	N/A	DWS Provided?	N/A
N/A	Landing Width (in)	N/A	N/A	DWS Contrast?	N/A
N/A	Landing Slope (%)	N/A	N/A	DWS Length (in)	N/A
N/A	Landing X Slope (%)	N/A	N/A	DWS Full Width?	N/A
N/A	Landing Curb? (Y/N)	N/A	N/A	DWS Offset (in)	N/A
N/A	Shared Landing?	N/A			
N/A	Gutter Ponding?	N/A	N/A	Gutter Slope (%)	N/A
N/A	Gutter Lip Ht (in)	N/A	N/A	Gutter X Slope (%)	N/A
N/A	Painted X Walk1?	No	N/A	Painted X Walk2?	N/A
	X Walk 1 Direction	To NW		X Walk 2 Direction	N/A
N/A	X Walk 1 Width (in)	N/A	N/A	X Walk 2 Width (in)	N/A
	X Walk 1 Slope (%)	1.6		X Walk 2 Slope (%)	N/A
	X Walk 1 X Slope (%)	5.4		X Walk 2 X Slope (%)	N/A

Remove & Replace Entire Ramp.
