Access Compliance Report

Public Rights-of-Way

(Curb Ramps)

Intersection ID: 7966	Main Street: PAWTUCKETT_RD	Cross Street: SWIFT_ARROW_LN	Location:	N
ADA ID: 2ABA6C2BFCFB	Ramp Type: Perp	Initial Pass/Fail: Fail	Overall Compliance: No	Severity Score: 22.5
Codes/Mitigation Info/Possible Solution		Field Measurements/Component Compliance

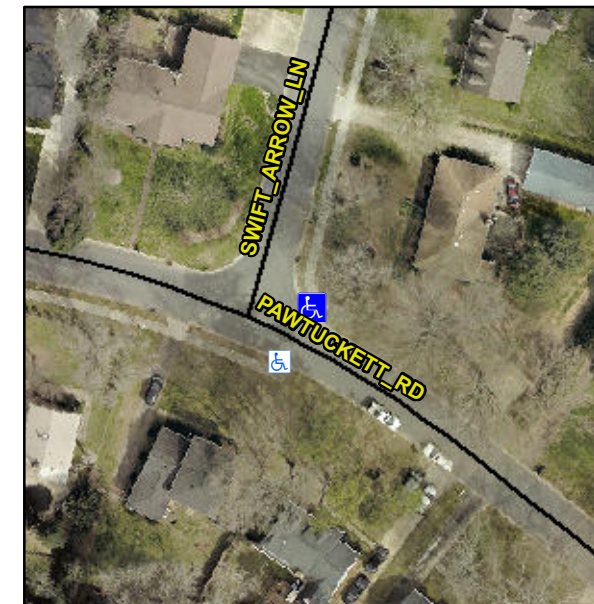
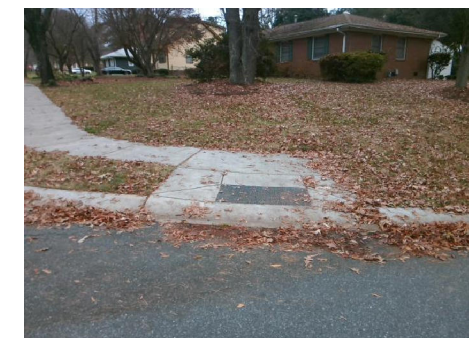
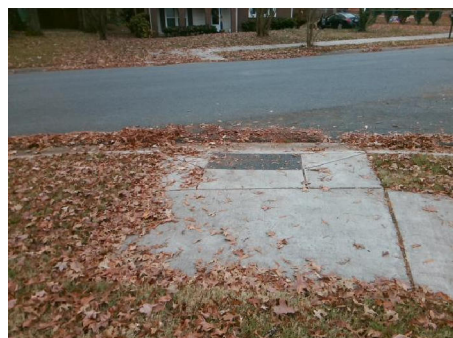
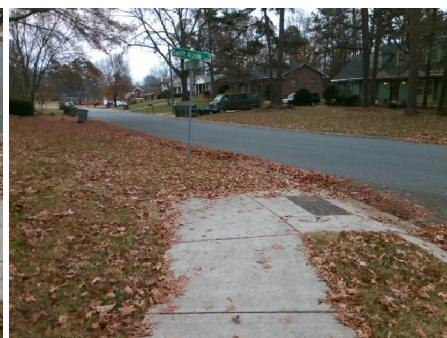
Not Found, R304.5.1, R304.2.2

Compliance	Description	Data	Compliance	Description	Data
N/A	Ramp Length (in)	46.0	No	Ramp Slope (%)	9.2
No	Ramp Width (in)	46.5	Yes	Ramp XSlope (%)	3.5
N/A	Flare Type LT	N/A	N/A	Flare Type RT	N/A
N/A	Flare Slope LT (%)	N/A	N/A	Flare Slope RT (%)	N/A
N/A	Flare Traversable LT?	N/A	N/A	Flare Traversable RT?	N/A
N/A	Landing Length (in)	N/A	N/A	DWS Provided?	N/A
N/A	Landing Width (in)	N/A	N/A	DWS Contrast?	N/A
N/A	Landing Slope (%)	N/A	N/A	DWS Length (in)	N/A
N/A	Landing X Slope (%)	N/A	N/A	DWS Full Width?	N/A
N/A	Landing Curb? (Y/N)	N/A	N/A	DWS Offset (in)	N/A
N/A	Shared Landing?	N/A			
N/A	Gutter Ponding?	N/A	N/A	Gutter Slope (%)	N/A
N/A	Gutter Lip Ht (in)	1.5	N/A	Gutter X Slope (%)	N/A
N/A	Painted X Walk1?	No	N/A	Painted X Walk2?	N/A
	X Walk 1 Direction	To SW		X Walk 2 Direction	N/A
N/A	X Walk 1 Width (in)	N/A	N/A	X Walk 2 Width (in)	N/A
	X Walk 1 Slope (%)	1.8		X Walk 2 Slope (%)	N/A
	X Walk 1 X Slope (%)	3.5		X Walk 2 X Slope (%)	N/A

N/A	Ramp inside XWalk1?	N/A	N/A	Ramp inside XWalk2?	N/A
	Road Slope (%)	N/A	N/A	Clear Space?	N/A
	Road X Slope (%)	N/A	N/A	Clear Space to XWalk (in)	N/A
N/A	Any Obstructions?	N/A	N/A	Storm Grate/Utility Hazard?	N/A
	Obstruction Type			Storm Grate/Utility Type	
		N/A			N/A
			Yes	Surface Condition? (G/P)	Good

Possible Solutions:

Remove & Replace Entire Ramp.
