Access Compliance Report Public Rights-of-Way (Curb Ramps)

Intersection ID: 24025 Main Street: SOUTH_LAKES_DR Cross Street: SOUTH_RIDGE_DR Location: S

ADA ID: 2ACAC004EFE8 Ramp Type: Perp Initial Pass/Fail: Fail Overall Compliance: No Severity Score: 12.5

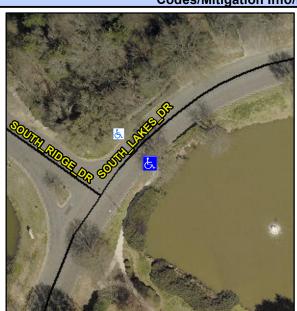
No Ramp Slope (%) N/A Ramp Length (in) 88.0 9.3 Yes Ramp XSlope (%) Yes Ramp Width (in) 48.0 1.2 N/A N/A Flare Type LT N/A Flare Type RT N/A N/A N/A N/A Flare Slope RT (%) N/A Flare Slope LT (%) N/A Flare Traversable LT? N/A N/A Flare Traversable RT? N/A N/A N/A N/A DWS Provided? N/A Landing Length (in) N/A Landing Width (in) N/A N/A **DWS Contrast?** N/A N/A N/A N/A Landing Slope (%) DWS Length (in) N/A N/A Landing X Slope (%) N/A N/A DWS Full Width? N/A N/A Landing Curb? (Y/N) N/A N/A DWS Offset (in) N/A N/A N/A Shared Landing? N/A **Gutter Ponding?** N/A N/A Gutter Slope (%) N/A N/A Gutter Lip Ht (in) N/A N/A Gutter X Slope (%) N/A N/A Painted X Walk1? No N/A Painted X Walk2? N/A X Walk 1 Direction To N X Walk 2 Direction N/A N/A N/A X Walk 1 Width (in) X Walk 2 Width (in) N/A X Walk 1 Slope (%) 2.8 X Walk 2 Slope (%) N/A X Walk 1 X Slope (%) 1.2 X Walk 2 X Slope (%) N/A N/A N/A N/A Ramp inside XWalk2? Ramp inside XWalk1? N/A Road Slope (%) N/A N/A Clear Space? N/A N/A Road X Slope (%) N/A Clear Space to XWalk (in) N/A N/A N/A Any Obstructions? N/A Storm Grate/Utility Hazard? N/A **Obstruction Type** Storm Grate/Utility Type N/A N/A Yes Surface Condition? (G/P) Good

Possible Solutions:

Remove & Replace Entire Ramp.
