Access Compliance Report Public Rights-of-Way (Curb Ramps)

Intersection ID: 10037443 Main Street: SCOTT AV Cross Street: N/A S Location: Initial Pass/Fail: Fail **Overall Compliance: No Severity Score:** 15 ADA ID: 2ACF04383103 Ramp Type: Combination2Diag

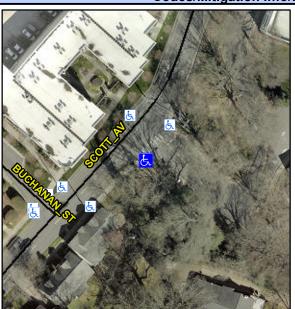
Landing Curb? (Y/N) N/A N/A DWS Offset (in) N/A Shared Landing? N/A **Gutter Ponding?** N/A N/A Gutter Slope (%) N/A N/A Gutter Lip Ht (in) N/A Gutter X Slope (%) N/A N/A Painted X Walk2? Painted X Walk1? Yes No To NE To NW X Walk 1 Direction X Walk 2 Direction X Walk 1 Width (in) 77.0 X Walk 2 Width (in) N/A 3.9 2.0 X Walk 1 Slope (%) X Walk 2 Slope (%) X Walk 1 X Slope (%) 5.6 X Walk 2 X Slope (%) 5.8 N/A Ramp inside XWalk1? Yes Ramp inside XWalk2? N/A Road Slope (%) 6.5 Clear Space? N/A Road X Slope (%) 1.3 N/A Clear Space to XWalk (in) N/A N/A Any Obstruction? N/A **Obstruction Type** N/A N/A Storm Grate/Utility Hazard? N/A Storm Grate/Utility Type N/A No Surface Condition? (G/P) Poor

Street 1 Name StopSign Stop Condition-Street 1 LOOP RD Street 2 Name None Stop Condition-Street 2 SCOTT AV Possible Solutions: Compliance Description N/A Remove & Replace Curb Ramp With Two New Directional Ramps or N/A Equivalent. N/A N/A N/A Yes Surveyor Notes: N/A N/A N/A N/A N/A N/A PROW/ADA: N/A R304.5.3, R304.3.2, R302.7 N/A N/A N/A N/A N/A N/A
