# Access Compliance Report

## Public Rights-of-Way

### (Curb Ramps)

Intersection ID: 50585	Main Street: GRAND_FIR_RD	Cross Street: BENDING_BRANCH_RD	Location: SE
ADA ID: 2AD1B6C071C3	Ramp Type: Perp	Initial Pass/Fail: Fail	Overall Compliance: No
Codes/Mitigation Info/Possible Solution			Severity Score: 35
			Field Measurements/Component Compliance

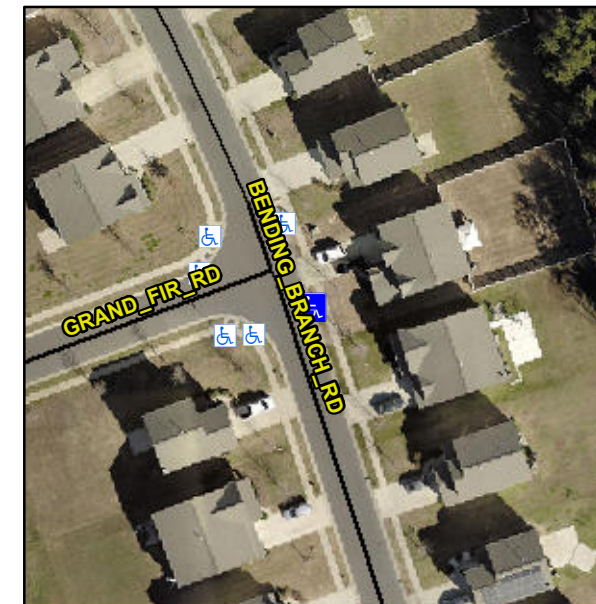
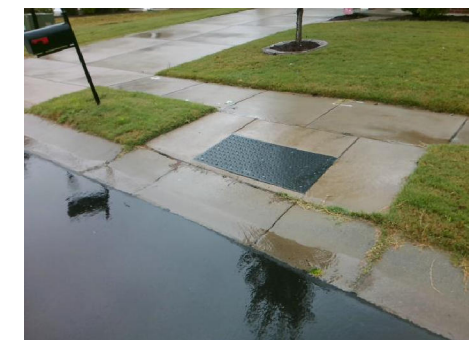
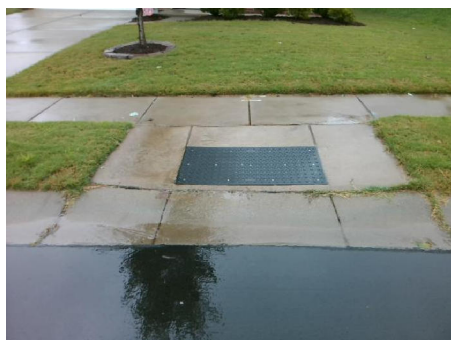
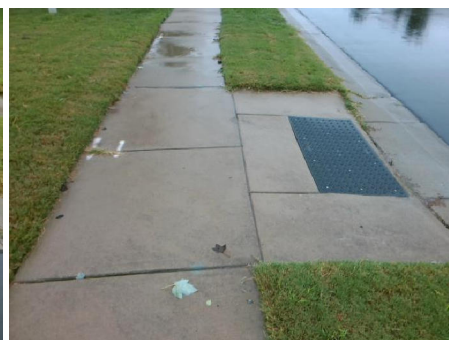
**Not Found, R304.5.1, R304.2.2, R304.5.3**

Compliance	Description	Data	Compliance	Description	Data
N/A	Ramp Length (in)	47.0	No	Ramp Slope (%)	14.8
No	Ramp Width (in)	47.5	No	Ramp XSlope (%)	3.5
N/A	Flare Type LT	N/A	N/A	Flare Type RT	N/A
N/A	Flare Slope LT (%)	N/A	N/A	Flare Slope RT (%)	N/A
N/A	Flare Traversable LT?	N/A	N/A	Flare Traversable RT?	N/A
N/A	Landing Length (in)	N/A	N/A	DWS Provided?	N/A
N/A	Landing Width (in)	N/A	N/A	DWS Contrast?	N/A
N/A	Landing Slope (%)	N/A	N/A	DWS Length (in)	N/A
N/A	Landing X Slope (%)	N/A	N/A	DWS Full Width?	N/A
N/A	Landing Curb? (Y/N)	N/A	N/A	DWS Offset (in)	N/A
N/A	Shared Landing?	N/A			
N/A	Gutter Ponding?	N/A	N/A	Gutter Slope (%)	N/A
N/A	Gutter Lip Ht (in)	N/A	N/A	Gutter X Slope (%)	N/A
N/A	Painted X Walk1?	No	N/A	Painted X Walk2?	N/A
	X Walk 1 Direction	To W		X Walk 2 Direction	N/A
N/A	X Walk 1 Width (in)	N/A	N/A	X Walk 2 Width (in)	N/A
	X Walk 1 Slope (%)	2.3		X Walk 2 Slope (%)	N/A
	X Walk 1 X Slope (%)	2.9		X Walk 2 X Slope (%)	N/A

N/A	Ramp inside XWalk1?	N/A	N/A	Ramp inside XWalk2?	N/A
	Road Slope (%)	N/A	N/A	Clear Space?	N/A
	Road X Slope (%)	N/A	N/A	Clear Space to XWalk (in)	N/A
N/A	Any Obstructions?	N/A	N/A	Storm Grate/Utility Hazard?	N/A
	Obstruction Type			Storm Grate/Utility Type	
		N/A			N/A
			Yes	Surface Condition? (G/P)	Good

**Remove & Replace Entire Ramp.**
