Access Compliance Report

Public Rights-of-Way

(Curb Ramps)

Intersection ID: 44886	Main Street: BERRYHILL_RD	Cross Street: BORDER_DR	Location:	N
ADA ID: 2ADD9940E837	Ramp Type: Perp	Initial Pass/Fail: Fail	Overall Compliance: No	Severity Score: 8.75

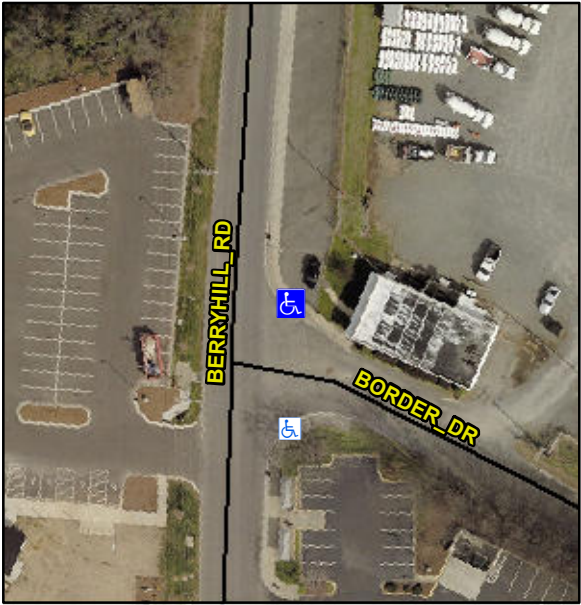
Possible Solutions:		Compliance	Description	Data	
	Remove & Replace Entire Ramp.		N/A	Ramp Length (in)	60.0	Yes
			No	Ramp Width (in)	44.0	Yes
			N/A	Flare Type LT	N/A	N/A
			N/A	Flare Slope LT (%)	N/A	N/A
			N/A	Flare Traversable LT?	N/A	N/A
			N/A	Landing Length (in)	N/A	N/A
			N/A	Landing Width (in)	N/A	N/A
			N/A	Landing Slope (%)	N/A	N/A
			N/A	Landing X Slope (%)	N/A	N/A
<p>Surveyor Notes:</p> <p>N/A</p>			N/A	Landing Curb? (Y/N)	N/A	N/A
			N/A	Shared Landing?	N/A	
			N/A	Gutter Ponding?	Yes	N/A
			N/A	Gutter Lip Ht (in)	0.5	N/A
			N/A	Painted X Walk1?	No	N/A
				X Walk 1 Direction	To S	
			N/A	X Walk 1 Width (in)	N/A	N/A
				X Walk 1 Slope (%)	1.7	
				X Walk 1 X Slope (%)	1.1	
			N/A	Ramp inside XWalk1?	N/A	N/A
<p>PROW/ADA:</p> <p>Not Found, R304.5.1</p>				Road Slope (%)	N/A	N/A
				Road X Slope (%)	N/A	N/A
			N/A	Any Obstructions?	N/A	N/A

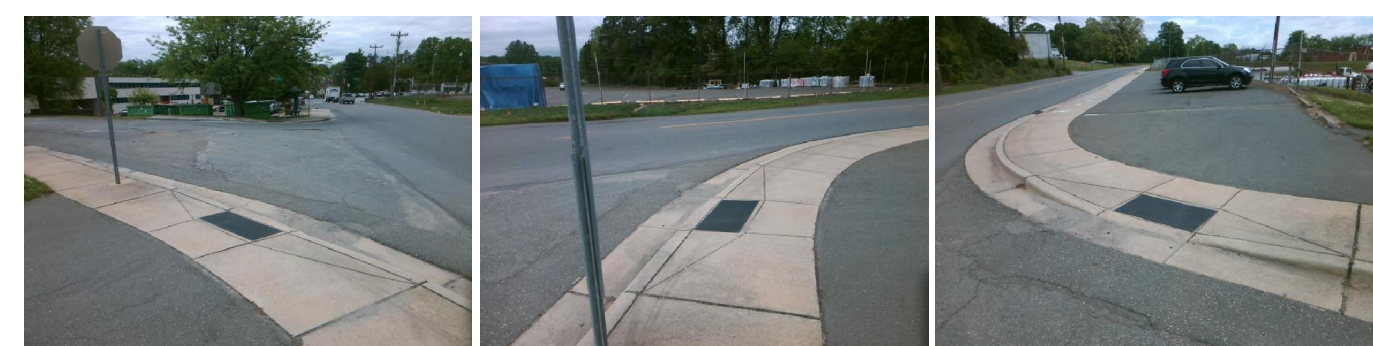
Obstruction Type		
					N/A	N/A
					N/A	N/A
					N/A	N/A
					N/A	N/A
					N/A	N/A
					N/A	N/A
					N/A	N/A
Total Cost:		\$ 1850.00				
						Yes
						Surface Condition? (G/P)
						Good
