Access Compliance Report

Public Rights-of-Way

(Curb Ramps)

Intersection ID: 11815	Main Street: N_POPLAR_ST	Cross Street: W_7TH_ST	Location: E
ADA ID: 2ADE4DF72ADB	Ramp Type: PerpDiag	Initial Pass/Fail: Fail	Overall Compliance: No
		Severity Score: 22.5

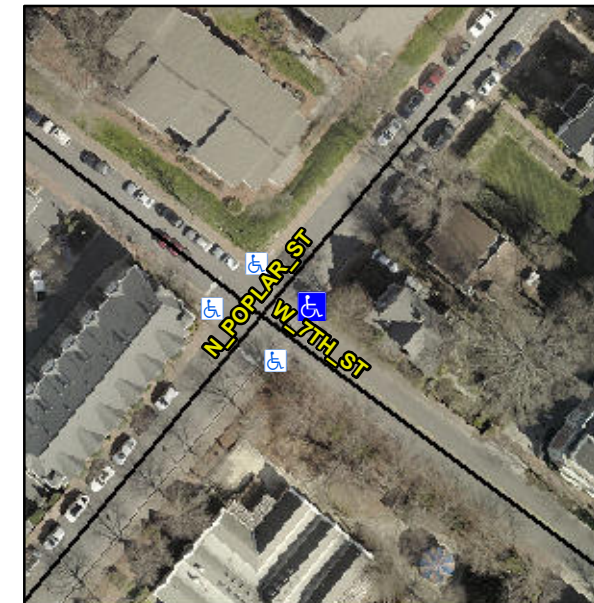
Not Found, R304.5.1, R304.2.2, R304.5.3

Compliance	Description	Data	Compliance	Description	Data
N/A	Ramp Length (in)	49.0	No	Ramp Slope (%)	9.6
No	Ramp Width (in)	38.0	No	Ramp XSlope (%)	2.9
N/A	Flare Type LT	N/A	N/A	Flare Type RT	N/A
N/A	Flare Slope LT (%)	N/A	N/A	Flare Slope RT (%)	N/A
N/A	Flare Traversable LT?	N/A	N/A	Flare Traversable RT?	N/A
N/A	Landing Length (in)	N/A	N/A	DWS Provided?	N/A
N/A	Landing Width (in)	N/A	N/A	DWS Contrast?	N/A
N/A	Landing Slope (%)	N/A	N/A	DWS Length (in)	N/A
N/A	Landing X Slope (%)	N/A	N/A	DWS Full Width?	N/A
N/A	Landing Curb? (Y/N)	N/A	N/A	DWS Offset (in)	N/A
N/A	Shared Landing?	N/A			
N/A	Gutter Ponding?	N/A	N/A	Gutter Slope (%)	N/A
N/A	Gutter Lip Ht (in)	N/A	N/A	Gutter X Slope (%)	N/A
N/A	Painted X Walk1?	No	N/A	Painted X Walk2?	No
	X Walk 1 Direction	To NW		X Walk 2 Direction	To SW
N/A	X Walk 1 Width (in)	N/A	N/A	X Walk 2 Width (in)	N/A
	X Walk 1 Slope (%)	4.2		X Walk 2 Slope (%)	3.5
	X Walk 1 X Slope (%)	2.9		X Walk 2 X Slope (%)	0.9

Remove & Replace Curb Ramp With Two New Directional Ramps or Equivalent.
