# Access Compliance Report

## Public Rights-of-Way

### (Curb Ramps)

Intersection ID: 3299	Main Street: BRANTHURST_DR	Cross Street: SPRING_PARK_DR	Location: E
ADA ID: 2AECAC4CDE4E	Ramp Type: Perp	Initial Pass/Fail: Fail	Overall Compliance: No
Severity Score: 46.25			
Codes/Mitigation Info/Possible Solution		Field Measurements/Component Compliance

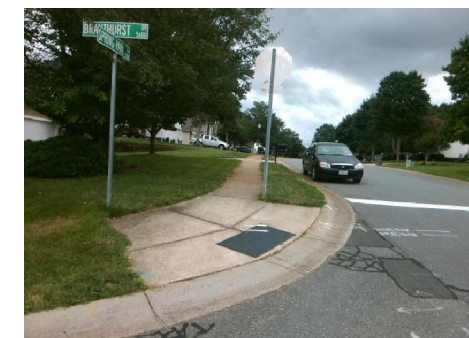
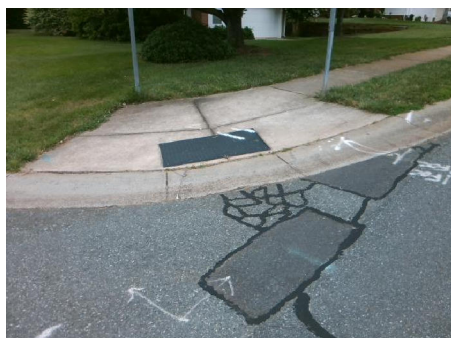
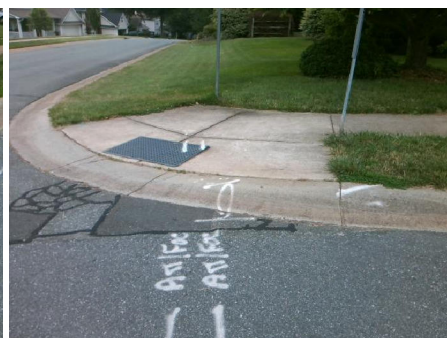
**Not Found, R304.5.1, R304.2.2, R304.5.3**

Compliance	Description	Data	Compliance	Description	Data
N/A	Ramp Length (in)	40.0	No	Ramp Slope (%)	8.4
No	Ramp Width (in)	46.0	No	Ramp XSlope (%)	12.0
N/A	Flare Type LT	N/A	N/A	Flare Type RT	N/A
N/A	Flare Slope LT (%)	N/A	N/A	Flare Slope RT (%)	N/A
N/A	Flare Traversable LT?	N/A	N/A	Flare Traversable RT?	N/A
N/A	Landing Length (in)	N/A	N/A	DWS Provided?	N/A
N/A	Landing Width (in)	N/A	N/A	DWS Contrast?	N/A
N/A	Landing Slope (%)	N/A	N/A	DWS Length (in)	N/A
N/A	Landing X Slope (%)	N/A	N/A	DWS Full Width?	N/A
N/A	Landing Curb? (Y/N)	N/A	N/A	DWS Offset (in)	N/A
N/A	Shared Landing?	N/A			
N/A	Gutter Ponding?	N/A	N/A	Gutter Slope (%)	N/A
N/A	Gutter Lip Ht (in)	N/A	N/A	Gutter X Slope (%)	N/A
N/A	Painted X Walk1?	No	N/A	Painted X Walk2?	N/A
	X Walk 1 Direction	To NW		X Walk 2 Direction	N/A
N/A	X Walk 1 Width (in)	N/A	N/A	X Walk 2 Width (in)	N/A
	X Walk 1 Slope (%)	5.6		X Walk 2 Slope (%)	N/A
	X Walk 1 X Slope (%)	4.0		X Walk 2 X Slope (%)	N/A

N/A	Ramp inside XWalk1?	N/A	N/A	Ramp inside XWalk2?	N/A
	Road Slope (%)	N/A	N/A	Clear Space?	N/A
	Road X Slope (%)	N/A	N/A	Clear Space to XWalk (in)	N/A
N/A	Any Obstructions?	N/A	N/A	Storm Grate/Utility Hazard?	N/A
	Obstruction Type			Storm Grate/Utility Type	
		N/A			N/A
			Yes	Surface Condition? (G/P)	Good

**Remove & Replace Entire Ramp.**
