Access Compliance Report

Public Rights-of-Way

(Curb Ramps)

Intersection ID: 9129	Main Street: N_GRAHAM_ST	Cross Street: NORRIS_AV	Location: SE
ADA ID: 2AF4F972B865	Ramp Type: Combination1	Initial Pass/Fail: Fail	Overall Compliance: No
			Severity Score: 21.25

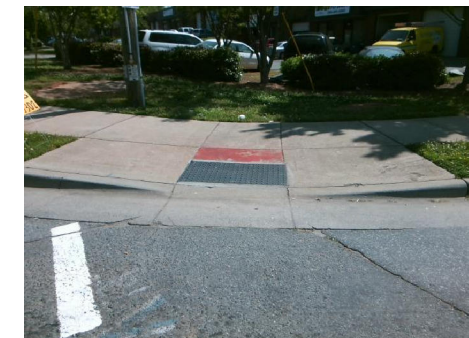
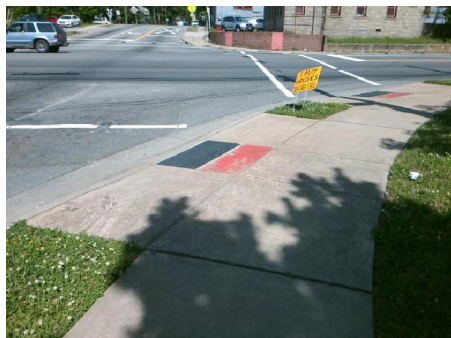
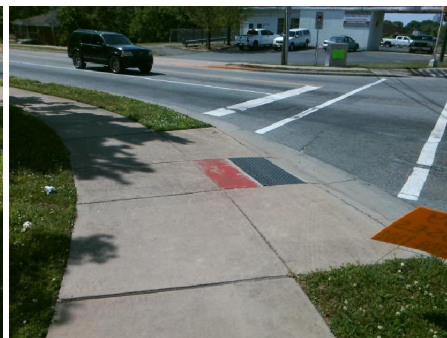
RT RP < 5%

Not Found, R304.5.1, R304.5.3

Compliance	Description	Data	Compliance	Description	Data
N/A	Ramp Length LT (in)	60.0	N/A	Ramp Length RT (in)	54.5
Yes	Ramp Width LT (in)	59.5	Yes	Ramp Width RT (in)	60.0
Yes	Ramp Slope LT (%)	6.6	Yes	Ramp Slope RT (%)	0.3
No	Ramp XSlope LT (%)	2.9	No	Ramp XSlope RT (%)	3.4
N/A	Ramp Length (in)	47.5	Yes	Ramp Slope (%)	6.3
No	Ramp Width (in)	45.0	No	Ramp XSlope (%)	5.1
N/A	Flare Type LT	N/A	N/A	Flare Type RT	N/A
N/A	Flare Slope LT (%)	N/A	N/A	Flare Slope RT (%)	N/A
N/A	Flare Traversable LT?	N/A	N/A	Flare Traversable RT?	N/A
N/A	Landing Length (in)	N/A	N/A	DWS Provided?	N/A
N/A	Landing Width (in)	N/A	N/A	DWS Contrast?	N/A
N/A	Landing Slope (%)	N/A	N/A	DWS Length (in)	N/A
N/A	Landing X Slope (%)	N/A	N/A	DWS Full Width?	N/A
N/A	Landing Curb? (Y/N)	N/A	N/A	DWS Offset (in)	N/A
N/A	Shared Landing?	N/A			
N/A	Gutter Ponding?	N/A	N/A	Gutter Slope (%)	N/A
N/A	Gutter Lip Ht (in)	N/A	N/A	Gutter X Slope (%)	N/A
N/A	Painted X Walk1?	Yes	N/A	Painted X Walk2?	N/A

Remove & Replace Entire Ramp.
