Access Compliance Report Public Rights-of-Way (Curb Ramps)

Intersection ID: 13343 Main Street: E INDEPENDENCE BV **Cross Street: CHARLOTTETOWNE AV** Location: ADA ID: 2B0965C499D5 Ramp Type: BlendTrans1 Initial Pass/Fail: Fail **Overall Compliance: No** Severity Score: 21.25

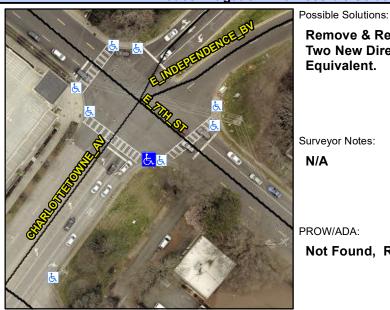
The state of the s									
	Colonia Colonia				N/A	Landing X Slope (%)	N/A	N/A	DWS Full Width?	N/A
	10				N/A	Landing Curb? (Y/N)	N/A	N/A	DWS Offset (in)	N/A
					N/A	Shared Landing?	N/A			
		PROW/ADA:			N/A	Gutter Ponding?	N/A	N/A	Gutter Slope (%)	N/A
	Park State	Not Found, R304.5	i.1, R304.5.	3	N/A	Gutter Lip Ht (in)	N/A	N/A	Gutter X Slope (%)	N/A
	A TOTAL STATE OF THE PARTY OF T	,	•		N/A	Painted X Walk1?	Yes	N/A	Painted X Walk2?	N/A
(// L						X Walk 1 Direction	To NW		X Walk 2 Direction	N/A
1 100000000000000000000000000000000000						X Walk 1 Width (in)	111.0		X Walk 2 Width (in)	N/A
Street 1 Name	CHARLOTTETOWNE AV					X Walk 1 Slope (%)	0.2		X Walk 2 Slope (%)	N/A
Stop Condition-Street 1	Signal					X Walk 1 X Slope (%)	1.4		X Walk 2 X Slope (%)	N/A
Street 2 Name	N/A				N/A	Ramp inside XWalk1?	Yes	N/A	Ramp inside XWalk2?	N/A
Stop Condition-Street 2	N/A					Road Slope (%)	1.4		Clear Space?	N/A
						Road X Slope (%)	0.2	N/A	Clear Space to XWalk (in)	N/A

N/A	Any Obstructions?	N/A	N/A	Storm Grate/Utility Hazard?	N/A
		Total Cost:	\$	3200.00		Obstruction Type			Storm Grate/Utility Type	
							N/A			N/A
								Yes	Surface Condition? (G/P)	Good
					· ·			No	Curb Slope (%)	13.2

Remove & Replace Curb Ramp With Two New Directional Ramps or Equivalent.
