# Access Compliance Report

## Public Rights-of-Way

| Intersection ID: 23318 | Main Street: SHARON_RD_WEST | Cross Street: WINTER_OAKS_LN | Location: NW |
| ADA ID: 2B11A232201D | Ramp Type: PerpDiag | Initial Pass/Fail: Fail | Overall Compliance: No |

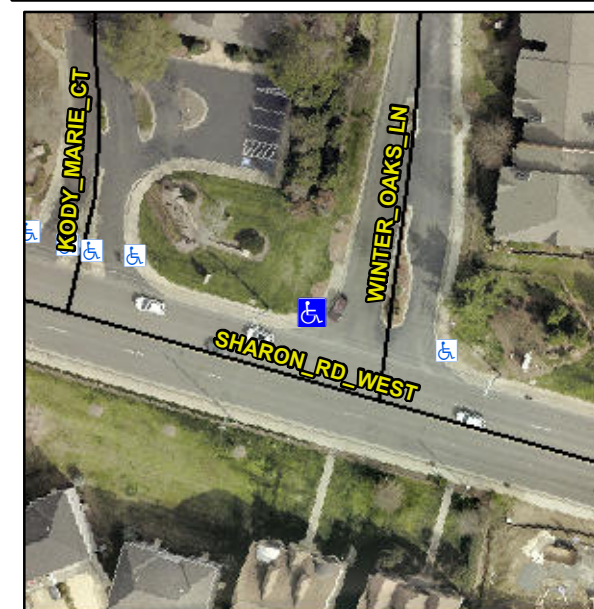
| Severity Score: 33.75 | | | |

| Compliance | Description | Data | Compliance | Description | Data |
|---|---|---|---|---|---|
| N/A | Ramp Length (in) | 59.0 | No | Ramp Slope (%) | 11.0 |
| No | Ramp Width (in) | 41.0 | No | Ramp XSlope (%) | 5.2 |

**Remove & Replace Curb Ramp With Two New Directional Ramps or Equivalent.**

**R304.5.1, R304.2.2, R304.5.3**

Total Cost: \$ 3200.00
