Access Compliance Report Public Rights-of-Way (Curb Ramps)

| Intersection ID: 30124 | Main Street: CLOONEY_LN | Cross Street: OLDE_JUSTIN_PL | Location: NE |
| ADA ID: 2B19F9FAB2E7 | Ramp Type: PerpDiag | Initial Pass/Fail: Fail | Overall Compliance: No Severity Score: 8.75 |

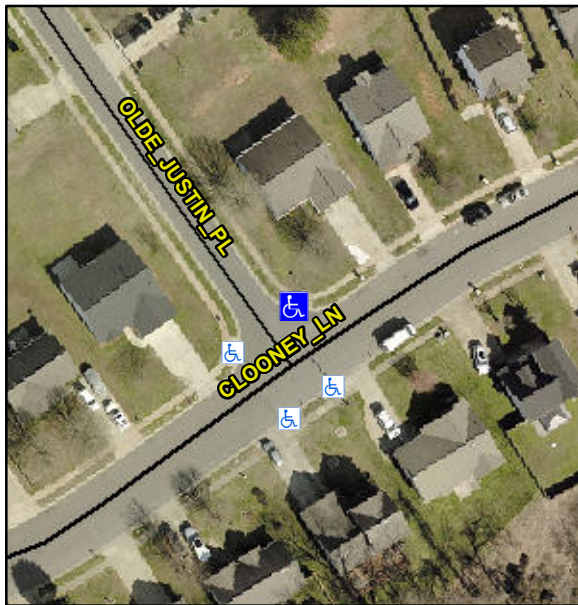
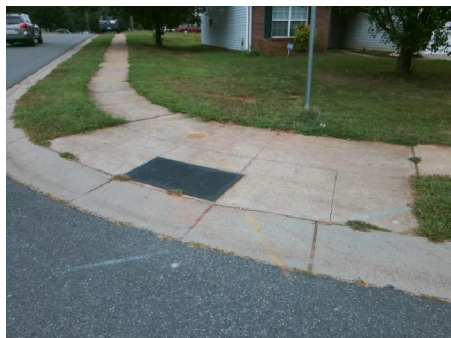
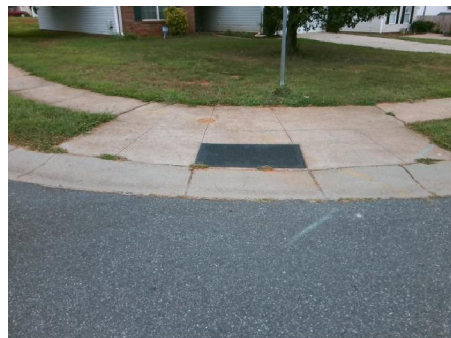
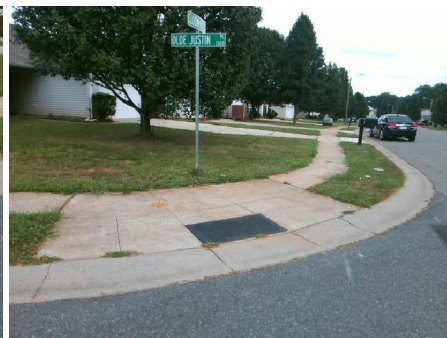
Not Found, R304.5.1

| Compliance | Description | Data | Compliance | Description | Data |
|---|---|---|---|---|---|
| No | Ramp Width (in) | 43.5 | Yes | Ramp XSlope (%) | 1.1 |
| N/A | Gutter Lip Ht (in) | 0.75 | N/A | Gutter X Slope (%) | N/A |

Remove & Replace Curb Ramp With Two New Directional Ramps or Equivalent.

Total Cost: \$ 3200.00
