Access Compliance Report

Public Rights-of-Way

(Curb Ramps)

Intersection ID: 8515	Main Street: ATANDO_AV	Cross Street: STATESVILLE_AV	Location: NW
ADA ID: 2B1F163DA5E1	Ramp Type: Para	Initial Pass/Fail: Pass	Overall Compliance: No
		Severity Score: 0

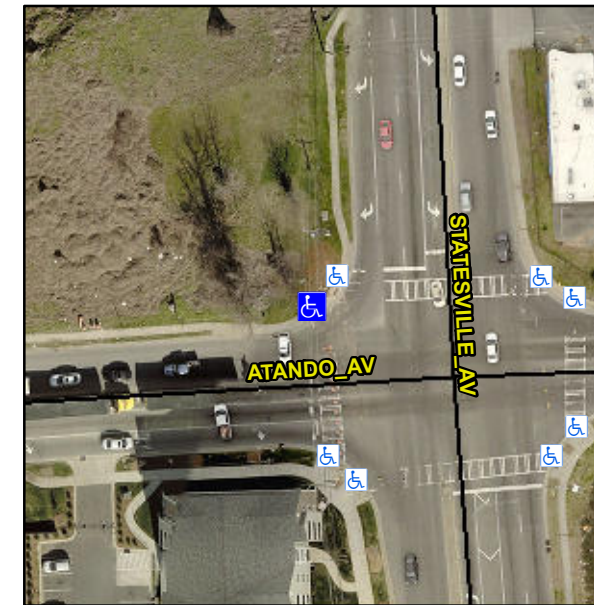
RT RP < 5%

Not Found, R304.2.1

Compliance	Description	Data	Compliance	Description	Data
N/A	Ramp Length LT (in)	64.0	N/A	Ramp Length RT (in)	60.0
Yes	Ramp Width LT (in)	60.0	Yes	Ramp Width RT (in)	60.0
Yes	Ramp Slope LT (%)	7.9	Yes	Ramp Slope RT (%)	3.1
Yes	Ramp XSlope LT (%)	1.7	Yes	Ramp XSlope RT (%)	1.0
Yes	Landing Length (in)	60.0	Yes	DWS Provided?	Yes
No	Landing Width (in)	42.0	Yes	DWS Contrast?	Yes
Yes	Landing Slope (%)	0.3	Yes	DWS Length (in)	25.0
Yes	Landing X Slope (%)	1.3	Yes	DWS Full Width?	Yes
N/A	Landing Curb? (Y/N)	No	Yes	DWS Offset (in)	1.0
N/A	Shared Landing?	No			
Yes	Gutter Ponding?	No	Yes	Gutter Slope (%)	2.8
Yes	Gutter Lip Ht (in)	0.0	Yes	Gutter X Slope (%)	0.7
N/A	Painted X Walk1?	No	N/A	Painted X Walk2?	N/A
	X Walk 1 Direction	To S		X Walk 2 Direction	N/A
N/A	X Walk 1 Width (in)	N/A	N/A	X Walk 2 Width (in)	N/A
	X Walk 1 Slope (%)	1.6		X Walk 2 Slope (%)	N/A
	X Walk 1 X Slope (%)	2.7		X Walk 2 X Slope (%)	N/A
N/A	Ramp inside XWalk1?	N/A	N/A	Ramp inside XWalk2?	N/A

Road Slope (%)	N/A	N/A	Clear Space?	Yes
	Road X Slope (%)	N/A	N/A	Clear Space to XWalk (in)	N/A
Yes	Any Obstructions?	No	Yes	Storm Grate/Utility Hazard?	No
	Obstruction Type			Storm Grate/Utility Type	
		N/A			N/A
			Yes	Surface Condition? (G/P)	Good
			Replace	Curb Slope (%)	20.4

Possible Solutions:

Remove & Replace Entire Ramp.
