Access Compliance Report

Public Rights-of-Way

(Curb Ramps)

Intersection ID: 21011	Main Street: CORONATION_BV	Cross Street: SARDIS_RD_NORTH	Location: NE
ADA ID: 2B2C844A3C89	Ramp Type: Perp	Initial Pass/Fail: Fail	Overall Compliance: No
Severity Score: 60			
Codes/Mitigation Info/Possible Solution		Field Measurements/Component Compliance

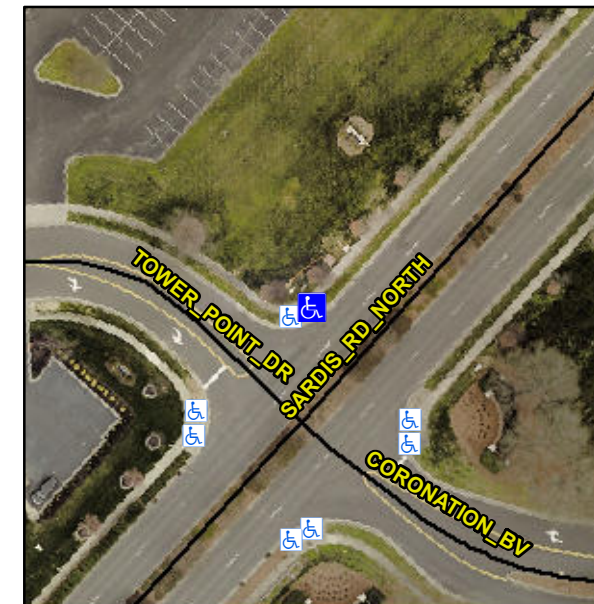
Not Found, R304.5.1, R304.2.2, R304.5.3

Compliance	Description	Data	Compliance	Description	Data
N/A	Ramp Length (in)	64.0	No	Ramp Slope (%)	8.5
No	Ramp Width (in)	31.0	No	Ramp XSlope (%)	5.7
N/A	Flare Type LT	N/A	N/A	Flare Type RT	N/A
N/A	Flare Slope LT (%)	N/A	N/A	Flare Slope RT (%)	N/A
N/A	Flare Traversable LT?	N/A	N/A	Flare Traversable RT?	N/A
N/A	Landing Length (in)	N/A	N/A	DWS Provided?	N/A
N/A	Landing Width (in)	N/A	N/A	DWS Contrast?	N/A
N/A	Landing Slope (%)	N/A	N/A	DWS Length (in)	N/A
N/A	Landing X Slope (%)	N/A	N/A	DWS Full Width?	N/A
N/A	Landing Curb? (Y/N)	N/A	N/A	DWS Offset (in)	N/A
N/A	Shared Landing?	N/A			
N/A	Gutter Ponding?	N/A	N/A	Gutter Slope (%)	N/A
N/A	Gutter Lip Ht (in)	N/A	N/A	Gutter X Slope (%)	N/A
N/A	Painted X Walk1?	No	N/A	Painted X Walk2?	N/A
	X Walk 1 Direction	To SE		X Walk 2 Direction	N/A
N/A	X Walk 1 Width (in)	N/A	N/A	X Walk 2 Width (in)	N/A
	X Walk 1 Slope (%)	1.3		X Walk 2 Slope (%)	N/A
	X Walk 1 X Slope (%)	6.4		X Walk 2 X Slope (%)	N/A

Remove & Replace Entire Ramp.

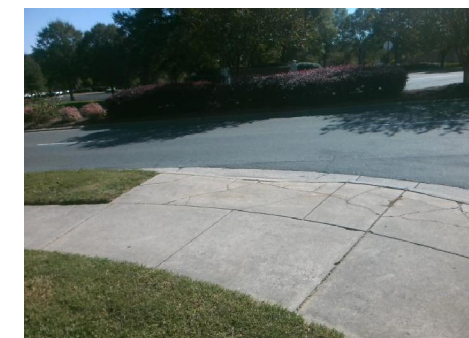
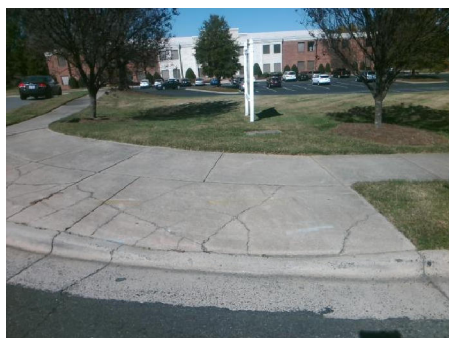
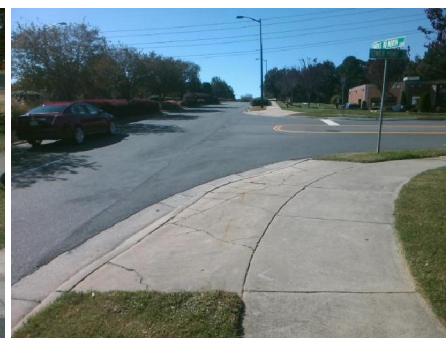
N/A	Ramp inside XWalk1?	N/A	N/A	Ramp inside XWalk2?	N/A
	Road Slope (%)	N/A	N/A	Clear Space?	N/A
	Road X Slope (%)	N/A	N/A	Clear Space to XWalk (in)	N/A
N/A	Any Obstructions?	N/A	N/A	Storm Grate/Utility Hazard?	N/A
	Obstruction Type			Storm Grate/Utility Type	
		N/A			N/A
			Yes	Surface Condition? (G/P)	Good
