# Access Compliance Report

## Public Rights-of-Way

| Intersection ID: 17772 | Main Street: IDLEWILD_RD | Cross Street: VALLEY GROVE RD | Location: SE |
| ADA ID: 2B3363DB856F | Ramp Type: Perp | Initial Pass/Fail: Fail | Overall Compliance: No |

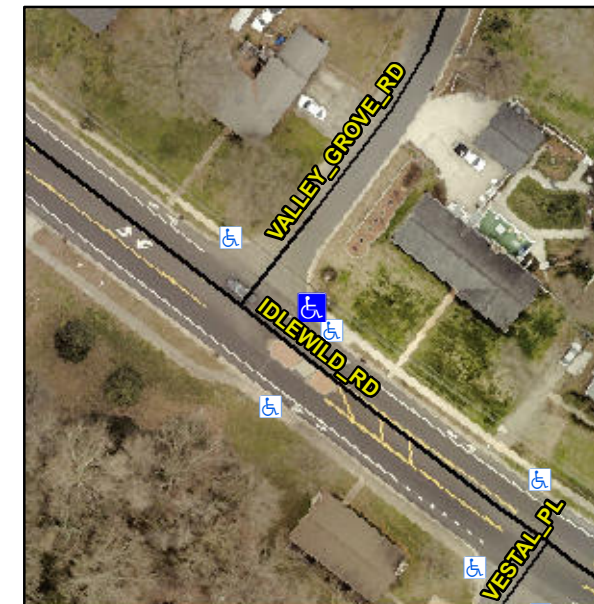
| | | Severity Score: 35 | |

**R304.5.1, R304.2.2, R304.5.3**

| Compliance | Description | Data | Compliance | Description | Data |
|---|---|---|---|---|---|
| N/A | Ramp Length (in) | 37.0 | No | Ramp Slope (%) | 16.7 |
| No | Ramp Width (in) | 42.0 | No | Ramp XSlope (%) | 3.9 |

**Remove & Replace Entire Ramp.**

Total Cost: \$ 1850.00
