Intersection ID: 19934	Main Street: W_ARROWWOOD_RD	Cross Street: WHITEWHITEHALL_EXECUTIVE_CENTER_DR	Location:	SW
ADA ID: 2B4AA6A700E7	Ramp Type: Combination1Diag	Initial Pass/Fail: Fail	Overall Compliance: No	Severity Score: 0

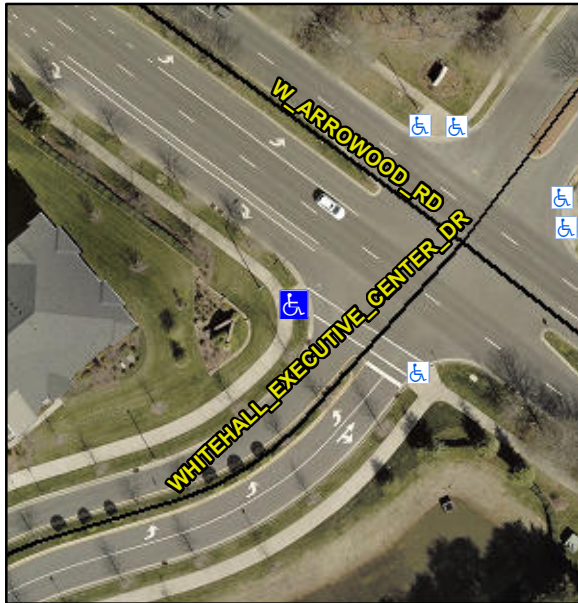
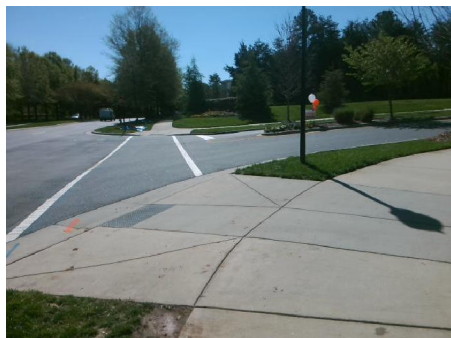
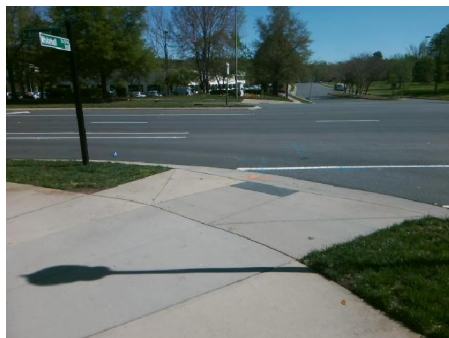
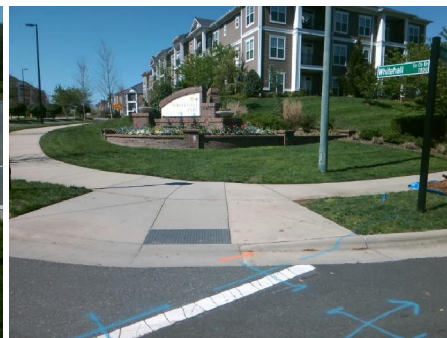
Not Found, R304.3.2

Compliance	Description	Data	Compliance	Description	Data
N/A	Ramp Length LT (in)	44.0	N/A	Ramp Length RT (in)	48.0
Yes	Ramp Width LT (in)	96.0	Yes	Ramp Width RT (in)	92.0
No	Ramp Slope LT (%)	8.5	Yes	Ramp Slope RT (%)	6.4
Yes	Ramp XSlope LT (%)	1.6	Yes	Ramp XSlope RT (%)	0.2
N/A	Ramp Length (in)	98.5	Yes	Ramp Slope (%)	6.3
Yes	Ramp Width (in)	48.0	Yes	Ramp XSlope (%)	0.7
N/A	Flare Type LT	N/A	N/A	Flare Type RT	N/A
N/A	Flare Slope LT (%)	N/A	N/A	Flare Slope RT (%)	N/A
N/A	Flare Traversable LT?	N/A	N/A	Flare Traversable RT?	N/A
N/A	Landing Length (in)	N/A	N/A	DWS Provided?	N/A
N/A	Landing Width (in)	N/A	N/A	DWS Contrast?	N/A
N/A	Landing Slope (%)	N/A	N/A	DWS Length (in)	N/A
N/A	Landing X Slope (%)	N/A	N/A	DWS Full Width?	N/A
N/A	Landing Curb? (Y/N)	N/A	N/A	DWS Offset (in)	N/A
N/A	Shared Landing?	N/A			
N/A	Gutter Ponding?	N/A	N/A	Gutter Slope (%)	N/A
N/A	Gutter Lip Ht (in)	N/A	N/A	Gutter X Slope (%)	N/A
N/A	Painted X Walk1?	Yes	N/A	Painted X Walk2?	No

X Walk 1 Direction	To SE		X Walk 2 Direction	To NE
	X Walk 1 Width (in)	112.0		X Walk 2 Width (in)	N/A
	X Walk 1 Slope (%)	3.4		X Walk 2 Slope (%)	0.7
	X Walk 1 X Slope (%)	2.6		X Walk 2 X Slope (%)	1.6
N/A	Ramp inside XWalk1?	Yes	N/A	Ramp inside XWalk2?	N/A
	Road Slope (%)	2.2		Clear Space?	N/A
	Road X Slope (%)	0.1	N/A	Clear Space to XWalk (in)	N/A
			N/A	Any Obstruction?	N/A
				Obstruction Type	N/A
			N/A	Storm Grate/Utility Hazard?	N/A
				Storm Grate/Utility Type	N/A
			Yes	Surface Condition? (G/P)	Good
				Curb Slope (%)	9.8

Remove & Replace Curb Ramp With Two New Directional Ramps or Equivalent.
