# Access Compliance Report

## Public Rights-of-Way

### (Curb Ramps)

Intersection ID: 7270	Main Street: CANTERWOOD_DR	Cross Street: TOM_HUNTER_RD	Location: SW
ADA ID: 2B4FE261ECAD	Ramp Type: PerpDiag	Initial Pass/Fail: Fail	Overall Compliance: No
Severity Score: 10			
Codes/Mitigation Info/Possible Solution		Field Measurements/Component Compliance

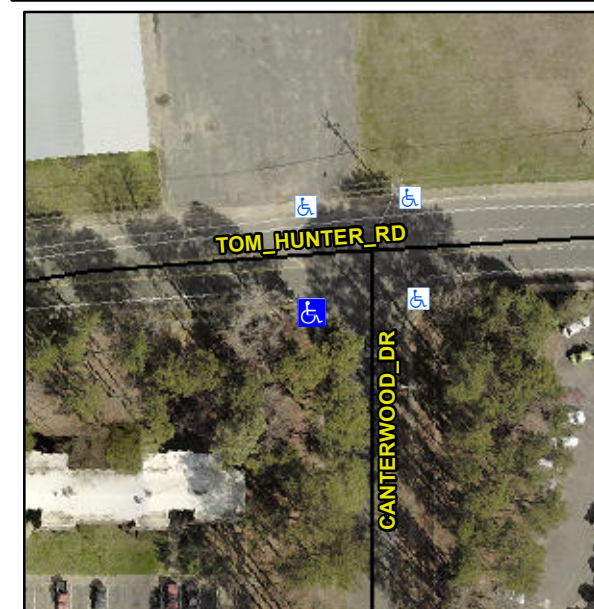
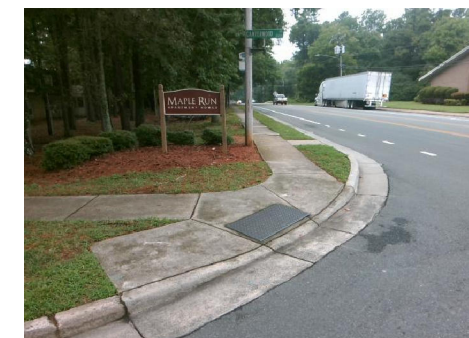
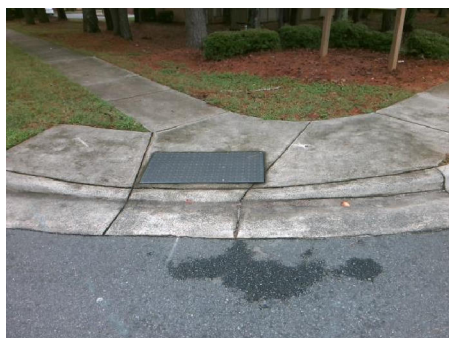
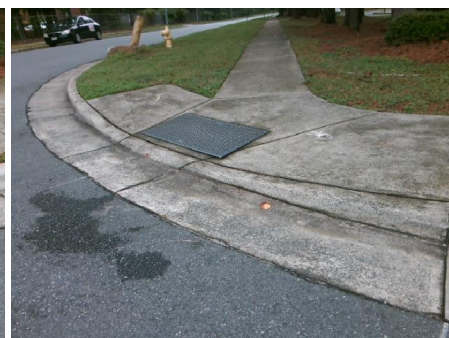
**Not Found, R304.5.1, R304.5.3**

Compliance	Description	Data	Compliance	Description	Data
N/A	Ramp Length (in)	48.0	Yes	Ramp Slope (%)	8.3
No	Ramp Width (in)	44.0	No	Ramp XSlope (%)	2.2
N/A	Flare Type LT	N/A	N/A	Flare Type RT	N/A
N/A	Flare Slope LT (%)	N/A	N/A	Flare Slope RT (%)	N/A
N/A	Flare Traversable LT?	N/A	N/A	Flare Traversable RT?	N/A
N/A	Landing Length (in)	N/A	N/A	DWS Provided?	N/A
N/A	Landing Width (in)	N/A	N/A	DWS Contrast?	N/A
N/A	Landing Slope (%)	N/A	N/A	DWS Length (in)	N/A
N/A	Landing X Slope (%)	N/A	N/A	DWS Full Width?	N/A
N/A	Landing Curb? (Y/N)	N/A	N/A	DWS Offset (in)	N/A
N/A	Shared Landing?	N/A			
N/A	Gutter Ponding?	N/A	N/A	Gutter Slope (%)	N/A
N/A	Gutter Lip Ht (in)	N/A	N/A	Gutter X Slope (%)	N/A
N/A	Painted X Walk1?	No	N/A	Painted X Walk2?	No
	X Walk 1 Direction	To E		X Walk 2 Direction	To N
N/A	X Walk 1 Width (in)	N/A	N/A	X Walk 2 Width (in)	N/A
	X Walk 1 Slope (%)	2.9		X Walk 2 Slope (%)	3.8
	X Walk 1 X Slope (%)	1.1		X Walk 2 X Slope (%)	1.3

N/A	Ramp inside XWalk1?	N/A	N/A	Ramp inside XWalk2?	N/A
	Road Slope (%)	0.2	N/A	Clear Space?	N/A
	Road X Slope (%)	5.2	N/A	Clear Space to XWalk (in)	N/A
N/A	Any Obstructions?	N/A	N/A	Storm Grate/Utility Hazard?	N/A
	Obstruction Type			Storm Grate/Utility Type	
		N/A			N/A
			Yes	Surface Condition? (G/P)	Good

**Remove & Replace Curb Ramp With Two New Directional Ramps or Equivalent.**

Total Cost: \$ 3200.00
