## **Access Compliance Report Public Rights-of-Way** (Curb Ramps)

Intersection ID: 3633 Main Street: COTA\_CT Cross Street: TREYMORE\_LN Location: N **Overall Compliance: No** ADA ID: 2B5739D4B677 Ramp Type: Perp Initial Pass/Fail: Fail **Severity Score:** 12.5

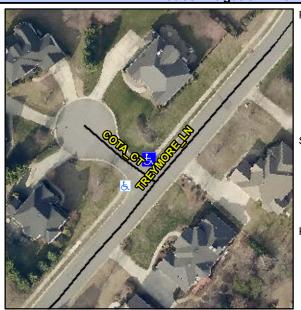
Tield Medadi ementa/Component Compnance							
Comp	liance Description	Data	Comp	oliance Description	Data			
N/A	Ramp Length (in)	50.0	Yes	Ramp Slope (%)	7.7			
Yes	Ramp Width (in)	78.0	No	Ramp XSlope (%)	6.6			
N/A	Flare Type LT	N/A	N/A	Flare Type RT	N/A			
N/A	Flare Slope LT (%)	N/A	N/A	Flare Slope RT (%)	N/A			
N/A	Flare Traversable LT?	N/A	N/A	Flare Traversable RT?	N/A			
N/A	Landing Length (in)	N/A	N/A	DWS Provided?	N/A			
N/A	Landing Width (in)	N/A	N/A	DWS Contrast?	N/A			
N/A	Landing Slope (%)	N/A	N/A	DWS Length (in)	N/A			
N/A	Landing X Slope (%)	N/A	N/A	DWS Full Width?	N/A			
N/A	Landing Curb? (Y/N)	N/A	N/A	DWS Offset (in)	N/A			
N/A	Shared Landing?	N/A						
N/A	Gutter Ponding?	N/A	N/A	Gutter Slope (%)	N/A			
N/A	Gutter Lip Ht (in)	N/A	N/A	Gutter X Slope (%)	N/A			
N/A	Painted X Walk1?	No	N/A	Painted X Walk2?	N/A			
	X Walk 1 Direction	To SW		X Walk 2 Direction	N/A			
N/A	X Walk 1 Width (in)	N/A	N/A	X Walk 2 Width (in)	N/A

X Walk 1 Slope (%)	3.4		X Walk 2 Slope (%)	N/A			
	X Walk 1 X Slope (%)	2.3		X Walk 2 X Slope (%)	N/A			
N/A	Ramp inside XWalk1?	N/A	N/A	Ramp inside XWalk2?	N/A			
	Road Slope (%)	N/A	N/A	Clear Space?	N/A			
	Road X Slope (%)	N/A	N/A	Clear Space to XWalk (in)	N/A			
N/A	Any Obstructions?	N/A	N/A	Storm Grate/Utility Hazard?	N/A			
	Obstruction Type			Storm Grate/Utility Type				
		N/A			N/A			
			Yes	Surface Condition? (G/P)	Good			
4

POSSIDIE SOIULIOII	
Possible Solutions:	Con
Remove & Replace Entire Ramp.	N/A
	Yes
	N/A
	N/A
	N/A
	N/A
Surveyor Notes:	N/A
N/A	N/A
	N/A
	N/A
	N/A
PROW/ADA:	N/A
Not Found, R304.5.3	N/A
	N/A
	N/A
	N/A

PROW/ADA:			IN/A
Not Found, R304.5.3			N/A
·			N/A
			N/A
			N/A
Total Cost:	¢	1850.00	N/A
IUIAI CUSI.	\$	1050.00
