Access Compliance Report

Public Rights-of-Way

(Curb Ramps)

Intersection ID: 17012	Main Street: MISSION_HILLS_RD	Cross Street: MORINGTON_LN	Location: NW
ADA ID: 2B628572DA57	Ramp Type: PerpDiag	Initial Pass/Fail: Fail	Overall Compliance: No
		Severity Score: 10

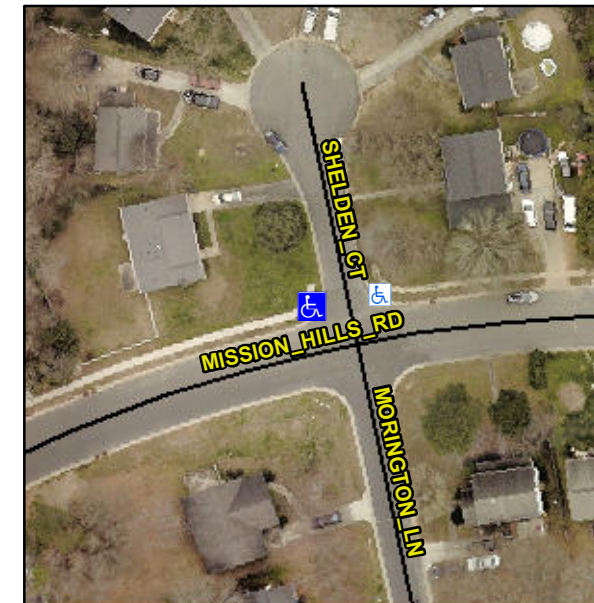
Compliance	Description	Data	Compliance	Description	Data
N/A	Ramp Length (in)	45.0	Yes	Ramp Slope (%)	5.8
No	Ramp Width (in)	47.0	No	Ramp XSlope (%)	4.8
N/A	Flare Type LT	N/A	N/A	Flare Type RT	N/A
N/A	Flare Slope LT (%)	N/A	N/A	Flare Slope RT (%)	N/A
N/A	Flare Traversable LT?	N/A	N/A	Flare Traversable RT?	N/A
N/A	Landing Length (in)	N/A	N/A	DWS Provided?	N/A
N/A	Landing Width (in)	N/A	N/A	DWS Contrast?	N/A
N/A	Landing Slope (%)	N/A	N/A	DWS Length (in)	N/A
N/A	Landing X Slope (%)	N/A	N/A	DWS Full Width?	N/A
N/A	Landing Curb? (Y/N)	N/A	N/A	DWS Offset (in)	N/A
N/A	Shared Landing?	N/A			
N/A	Gutter Ponding?	N/A	N/A	Gutter Slope (%)	N/A
N/A	Gutter Lip Ht (in)	N/A	N/A	Gutter X Slope (%)	N/A
N/A	Painted X Walk1?	No	N/A	Painted X Walk2?	No
	X Walk 1 Direction	To S		X Walk 2 Direction	To E
N/A	X Walk 1 Width (in)	N/A	N/A	X Walk 2 Width (in)	N/A
	X Walk 1 Slope (%)	4.5		X Walk 2 Slope (%)	6.6
	X Walk 1 X Slope (%)	3.4		X Walk 2 X Slope (%)	4.9

N/A	Ramp inside XWalk1?	N/A	N/A	Ramp inside XWalk2?	N/A
	Road Slope (%)	2.6	N/A	Clear Space?	N/A
	Road X Slope (%)	1.6	N/A	Clear Space to XWalk (in)	N/A
N/A	Any Obstructions?	N/A	N/A	Storm Grate/Utility Hazard?	N/A
	Obstruction Type			Storm Grate/Utility Type	
		N/A			N/A
			Yes	Surface Condition? (G/P)	Good

Remove & Replace Curb Ramp With Two New Directional Ramps or Equivalent.

Not Found, R304.5.1, R304.5.3
