# Access Compliance Report

## Public Rights-of-Way

### (Curb Ramps)

Intersection ID: 53912	Main Street: BRITTONDALE_LN	Cross Street: PINYON_PINE_LN	Location: NW
ADA ID: 2B629C3AC623	Ramp Type: PerpDiag	Initial Pass/Fail: Fail	Overall Compliance: No
			Severity Score: 13.75

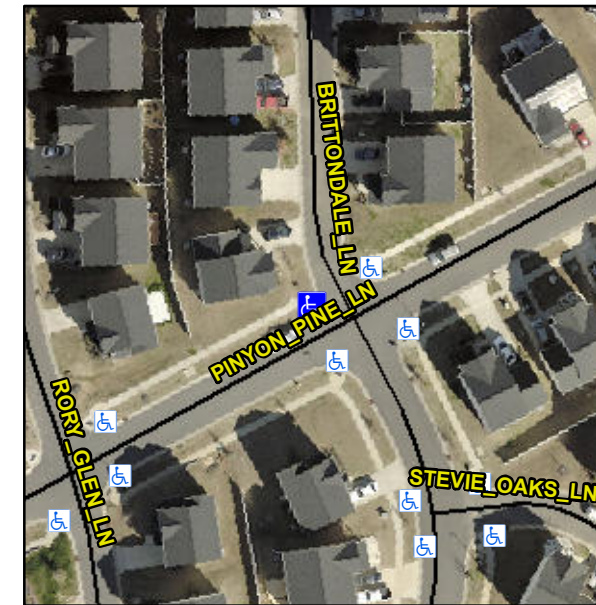
**Not Found, R304.2.2, R304.5.3**

Compliance	Description	Data	Compliance	Description	Data
N/A	Ramp Length (in)	103.0	No	Ramp Slope (%)	9.2
Yes	Ramp Width (in)	49.5	No	Ramp XSlope (%)	4.0
N/A	Flare Type LT	N/A	N/A	Flare Type RT	N/A
N/A	Flare Slope LT (%)	N/A	N/A	Flare Slope RT (%)	N/A
N/A	Flare Traversable LT?	N/A	N/A	Flare Traversable RT?	N/A
N/A	Landing Length (in)	N/A	N/A	DWS Provided?	N/A
N/A	Landing Width (in)	N/A	N/A	DWS Contrast?	N/A
N/A	Landing Slope (%)	N/A	N/A	DWS Length (in)	N/A
N/A	Landing X Slope (%)	N/A	N/A	DWS Full Width?	N/A
N/A	Landing Curb? (Y/N)	N/A	N/A	DWS Offset (in)	N/A
N/A	Shared Landing?	N/A			
N/A	Gutter Ponding?	N/A	N/A	Gutter Slope (%)	N/A
N/A	Gutter Lip Ht (in)	N/A	N/A	Gutter X Slope (%)	N/A
N/A	Painted X Walk1?	No	N/A	Painted X Walk2?	No
	X Walk 1 Direction	To E		X Walk 2 Direction	To S
N/A	X Walk 1 Width (in)	N/A	N/A	X Walk 2 Width (in)	N/A
	X Walk 1 Slope (%)	5.0		X Walk 2 Slope (%)	1.3
	X Walk 1 X Slope (%)	1.8		X Walk 2 X Slope (%)	4.6

N/A	Ramp inside XWalk1?	N/A	N/A	Ramp inside XWalk2?	N/A
	Road Slope (%)	3.7	N/A	Clear Space?	N/A
	Road X Slope (%)	3.6	N/A	Clear Space to XWalk (in)	N/A
N/A	Any Obstructions?	N/A	N/A	Storm Grate/Utility Hazard?	N/A
	Obstruction Type			Storm Grate/Utility Type	
		N/A			N/A
			Yes	Surface Condition? (G/P)	Good

**Remove & Replace Curb Ramp With Two New Directional Ramps or Equivalent.**

Total Cost: \$ 3200.00

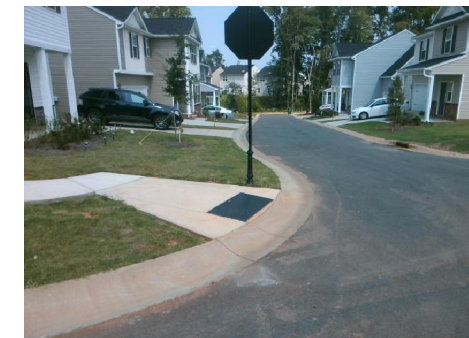
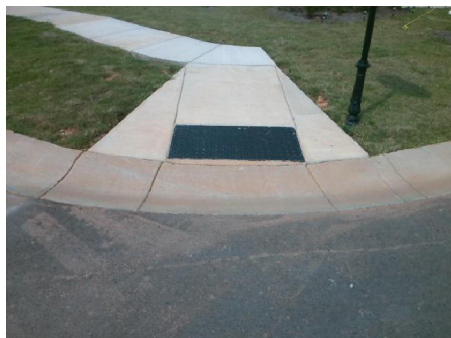
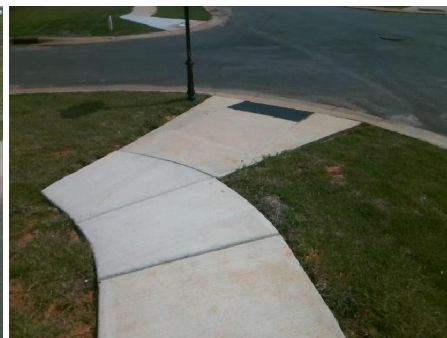
Street 1 Name PINYON PINE LN  
 Stop Condition-Street 2 None  
 Street 2 Name BRITTONDALE LN  
 Stop Condition-Street 1 StopSign
