Access Compliance Report

Public Rights-of-Way (Curb Ramps)

Intersection ID: 24782	Main Street: BLACK_DUCK_CT	Cross Street: CANVASBACK_DR	Location: SW
ADA ID: 2B62DB3DB3DE	Ramp Type: Directional1	Initial Pass/Fail: Fail	Overall Compliance: No
		Severity Score: 12.5

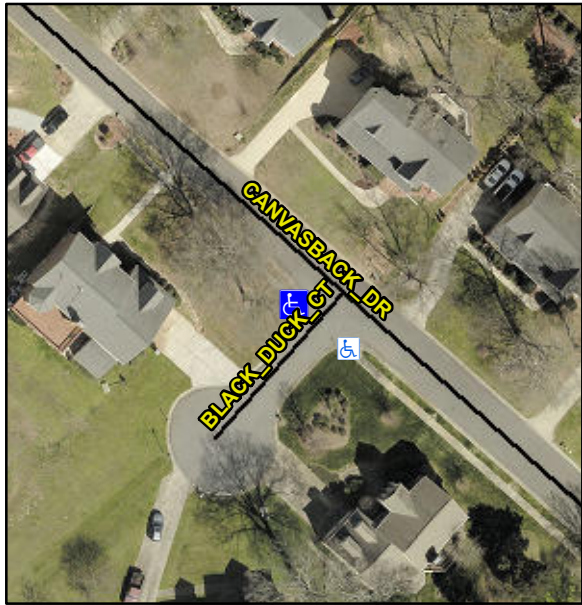
Possible Solutions:		Compliance	Description	Data	Compliance	Description	Data
	Remove & Replace Entire Ramp.		N/A	Ramp Length (in)	37.0	N/A	Grade Break?	N/A
			Yes	Ramp Width (in)	48.0	N/A	Grade Break Slope (%)	0.0
			No	Ramp Slope (%)	10.2	N/A	Grade Break XSlope (%)	0.0
			Yes	Ramp XSlope (%)	1.3			
			N/A	Flare Type LT	N/A	N/A	Flare Type RT	N/A
			N/A	Flare Slope LT (%)	N/A	N/A	Flare Slope RT (%)	0.0
			N/A	Flare Traversable LT?	N/A	N/A	Flare Traversable RT?	N/A
			N/A	Landing Length (in)	0.0	N/A	DWS Provided?	N/A
			N/A	Landing Width (in)	0.0	N/A	DWS Contrast?	N/A
Surveyor Notes:		N/A	N/A	Landing Slope (%)	0.0	N/A	DWS Length (in)	N/A
		N/A	N/A	Landing X Slope (%)	0.0	N/A	DWS Full Width?	N/A
PROW/ADA:		N/A	N/A	Landing Curb? (Y/N)	N/A	N/A	DWS Offset LT (in)	N/A
R304.2.2		N/A	N/A	Shared Landing?	N/A	N/A	DWS Offset RT (in)	N/A

N/A	N/A	Gutter Ponding?	0.0	N/A	Gutter Slope (%)	N/A
		N/A	N/A	Gutter Lip Ht (in)	0.0	N/A	Gutter X Slope (%)	N/A
		N/A	N/A	Painted X Walk1?	No		Road Slope (%)	0.1
				X Walk 1 Direction	To SE		Road X Slope (%)	2.5
				X Walk 1 Width (in)	N/A		Clear Space?	N/A
				X Walk 1 Slope (%)	0.1	N/A	Clear Space to XWalk (in)	N/A
				X Walk 1 X Slope (%)	2.5	N/A	Storm Grate/Utility Hazard?	N/A
		N/A	N/A	Ramp inside XWalk1?	N/A		Storm Grate/Utility Type	
		N/A	N/A	Any Obstructions?	N/A			N/A
				Obstruction Type		Yes	Surface Condition? (G/P)	Good
					N/A	N/A	Curb Slope (%)	32.5
Total Cost:		\$ 1600.00
