Access Compliance Report Public Rights-of-Way (Curb Ramps)

Intersection ID: 29529	Main Street: E_W_T_HARRIS_BV		Cross S	Cross Street: CAMPBELL_BURN_CT				Location:	NW
ADA ID: 2B71F1428DA4	Ramp Type: PerpDiag		Initial P	nitial Pass/Fail: Fail Overall Compliance: No				o Severity Score:	8.75
Codes/Mitigation Info/Possible Solution				Field Measurements/Component Compliance					
		Possible Solutions:		Compliance Description		Data Compliance Description			Data
		Remove & Replace Curb Ramp V	Vith	N/A	Ramp Length (in)	85.0	Yes	Ramp Slope (%)	6.8
		Two New Directional Ramps or		No	Ramp Width (in)	41.0	Yes	Ramp XSlope (%)	0.2
		Equivalent.		N/A	Flare Type LT	N/A	N/A	Flare Type RT	N/A
				N/A	Flare Slope LT (%)	N/A	N/A	Flare Slope RT (%)	N/A
				N/A	Flare Traversable LT?	N/A	N/A	Flare Traversable RT?	N/A
CAMPBELL BURN CT				N/A	Landing Length (in)	N/A	N/A	DWS Provided?	N/A
CAMPORES		Surveyor Notes:		N/A	Landing Width (in)	N/A	N/A	DWS Contrast?	N/A

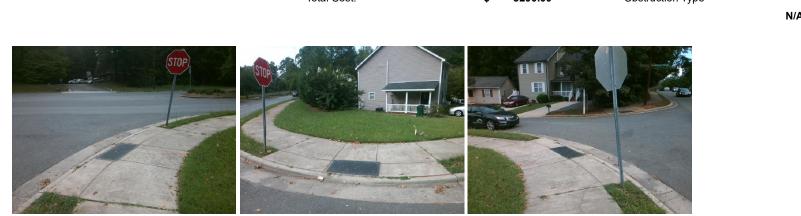
- En th		N/A		N/A	Landing Slope (%)	N/A	N/A	DWS Length (in)	N/A
		Ś.		N/A	Landing X Slope (%)	N/A	N/A	DWS Full Width?	N/A
		2		N/A	Landing Curb? (Y/N)	N/A	N/A	DWS Offset (in)	N/A
				N/A	Shared Landing?	N/A			
		PROW/ADA:		N/A	Gutter Ponding?	N/A	N/A	Gutter Slope (%)	N/A
	PALINE	Not Found, R304.5.1		N/A	Gutter Lip Ht (in)	N/A	N/A	Gutter X Slope (%)	N/A
AL ROLL		· ·		N/A	Painted X Walk1?	No	N/A	Painted X Walk2?	No
Contract of the second					X Walk 1 Direction	To SE		X Walk 2 Direction	To NE
4 Burka Set 1				N/A	X Walk 1 Width (in)	N/A	N/A	X Walk 2 Width (in)	N/A
Street 1 Name	E W T HARRIS BV				X Walk 1 Slope (%)	5.6		X Walk 2 Slope (%)	6.1
Stop Condition-Street 2	None				X Walk 1 X Slope (%)	3.5		X Walk 2 X Slope (%)	3.6
Street 2 Name	CAMPBELL BURN CT			N/A	Ramp inside XWalk1?	N/A	N/A	Ramp inside XWalk2?	N/A
Stop Condition-Street 1	StopSign				Road Slope (%)	2.4	N/A	Clear Space?	N/A
					Road X Slope (%)	4.3	N/A	Clear Space to XWalk (in)	N/A

N/A	Any Obstructions?	N/A	N/A	Storm Grate/Utility Hazard?	N/A
		Total Cost: \$ 3	200.00		Obstruction Type			Storm Grate/Utility Type	
						N/A			N/A
