# Access Compliance Report

## Public Rights-of-Way

### (Curb Ramps)

| Intersection ID: 26103 | Main Street: BEVINGTON_PL | Cross Street: COBURN_CT | Location: W |

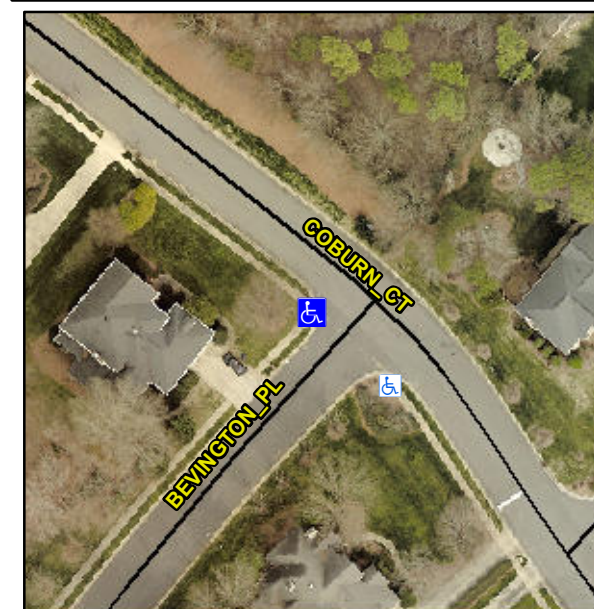
| ADA ID: 2B835F312EEA | Ramp Type: PerpDiag | Initial Pass/Fail: Fail | Overall Compliance: No |
| Severity Score: 30 | | | |

**Not Found, R304.5.1, R304.2.2**

| Compliance | Description | Data | Compliance | Description | Data |
|---|---|---|---|---|---|
| N/A | Ramp Length (in) | 85.0 | No | Ramp Slope (%) | 8.7 |
| No | Ramp Width (in) | 32.0 | Yes | Ramp XSlope (%) | 0.7 |

**Remove & Replace Curb Ramp With Two New Directional Ramps or Equivalent.**

Total Cost: \$ 3200.00
