Access Compliance Report

Public Rights-of-Way

(Curb Ramps)

Intersection ID: 49333	Main Street: MARGARET_WALLACE_RD	Cross Street: MINTWORTH_AV	Location: NW
ADA ID: 2B87C4A41737	Ramp Type: PerpDiag	Initial Pass/Fail: Fail	Overall Compliance: No
Severity Score: 13.75			
Codes/Mitigation Info/Possible Solution		Field Measurements/Component Compliance

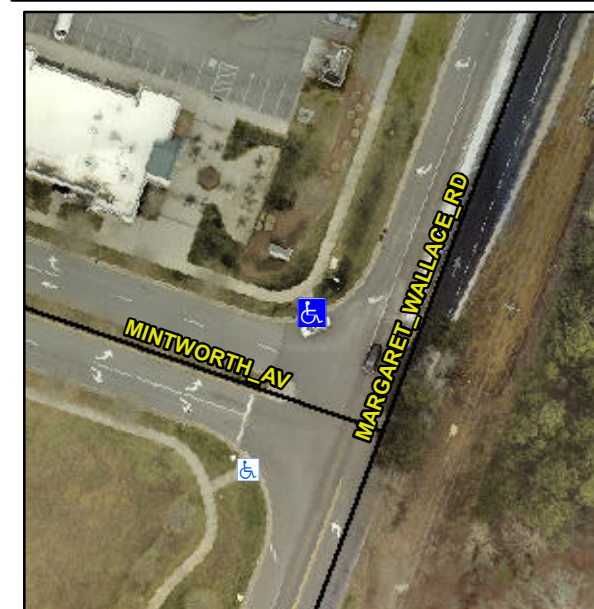
Not Found, R304.2.2, R304.5.3

Compliance	Description	Data	Compliance	Description	Data
N/A	Ramp Length (in)	48.0	No	Ramp Slope (%)	9.2
Yes	Ramp Width (in)	48.0	No	Ramp XSlope (%)	4.7
N/A	Flare Type LT	N/A	N/A	Flare Type RT	N/A
N/A	Flare Slope LT (%)	N/A	N/A	Flare Slope RT (%)	N/A
N/A	Flare Traversable LT?	N/A	N/A	Flare Traversable RT?	N/A
N/A	Landing Length (in)	N/A	N/A	DWS Provided?	N/A
N/A	Landing Width (in)	N/A	N/A	DWS Contrast?	N/A
N/A	Landing Slope (%)	N/A	N/A	DWS Length (in)	N/A
N/A	Landing X Slope (%)	N/A	N/A	DWS Full Width?	N/A
N/A	Landing Curb? (Y/N)	N/A	N/A	DWS Offset (in)	N/A
N/A	Shared Landing?	N/A			
N/A	Gutter Ponding?	N/A	N/A	Gutter Slope (%)	N/A
N/A	Gutter Lip Ht (in)	N/A	N/A	Gutter X Slope (%)	N/A
N/A	Painted X Walk1?	No	N/A	Painted X Walk2?	No
	X Walk 1 Direction	To SW		X Walk 2 Direction	To SE
N/A	X Walk 1 Width (in)	N/A	N/A	X Walk 2 Width (in)	N/A
	X Walk 1 Slope (%)	0.8		X Walk 2 Slope (%)	5.3
	X Walk 1 X Slope (%)	5.6		X Walk 2 X Slope (%)	0.7

N/A	Ramp inside XWalk1?	N/A	N/A	Ramp inside XWalk2?	N/A
	Road Slope (%)	5.3	N/A	Clear Space?	N/A
	Road X Slope (%)	3.7	N/A	Clear Space to XWalk (in)	N/A
N/A	Any Obstructions?	N/A	N/A	Storm Grate/Utility Hazard?	N/A
	Obstruction Type			Storm Grate/Utility Type	
		N/A			N/A
			Yes	Surface Condition? (G/P)	Good

Remove & Replace Curb Ramp With Two New Directional Ramps or Equivalent.
