Access Compliance Report

Public Rights-of-Way

(Curb Ramps)

Intersection ID: 21238	Main Street: CAROSAN_LN	Cross Street: SARDIS_LN	Location: NW
ADA ID: 2B8B7A3C93D0	Ramp Type: Directional1	Initial Pass/Fail: Fail	Overall Compliance: No
Severity Score: 12.5			
Codes/Mitigation Info/Possible Solution		Field Measurements/Component Compliance

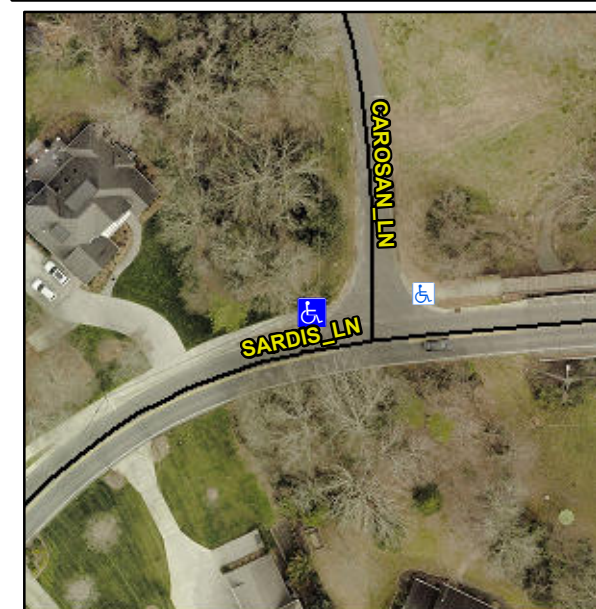
Compliance	Description	Data	Compliance	Description	Data
N/A	Ramp Length (in)	104.0	N/A	Grade Break?	N/A
Yes	Ramp Width (in)	76.0	N/A	Grade Break Slope (%)	0.0
No	Ramp Slope (%)	10.6	N/A	Grade Break XSlope (%)	0.0
Yes	Ramp XSlope (%)	1.3			
N/A	Flare Type LT	N/A	N/A	Flare Type RT	N/A
N/A	Flare Slope LT (%)	N/A	N/A	Flare Slope RT (%)	0.0
N/A	Flare Traversable LT?	N/A	N/A	Flare Traversable RT?	N/A
N/A	Landing Length (in)	0.0	N/A	DWS Provided?	N/A
N/A	Landing Width (in)	0.0	N/A	DWS Contrast?	N/A
N/A	Landing Slope (%)	0.0	N/A	DWS Length (in)	N/A
N/A	Landing X Slope (%)	0.0	N/A	DWS Full Width?	N/A
N/A	Landing Curb? (Y/N)	N/A	N/A	DWS Offset LT (in)	N/A
N/A	Shared Landing?	N/A	N/A	DWS Offset RT (in)	N/A
N/A	Gutter Ponding?	0.0	N/A	Gutter Slope (%)	N/A
N/A	Gutter Lip Ht (in)	0.0	N/A	Gutter X Slope (%)	N/A
N/A	Painted X Walk1?	No		Road Slope (%)	1.6
	X Walk 1 Direction	To NE		Road X Slope (%)	3.8
	X Walk 1 Width (in)	N/A		Clear Space?	N/A

X Walk 1 Slope (%)	1.6	N/A	Clear Space to XWalk (in)	N/A
	X Walk 1 X Slope (%)	3.8	N/A	Storm Grate/Utility Hazard?	N/A
N/A	Ramp inside XWalk1?	N/A		Storm Grate/Utility Type	
N/A	Any Obstructions?	N/A			N/A
	Obstruction Type		Yes	Surface Condition? (G/P)	Good
			N/A	Curb Slope (%)	2.7

Remove & Replace Entire Ramp.
