Access Compliance Report

Public Rights-of-Way

(Curb Ramps)

Intersection ID: 10477	Main Street: HAMILTON_ST	Cross Street: POLK_ST	Location: W
ADA ID: 2B8B9519CEAE	Ramp Type: Perp	Initial Pass/Fail: Fail	Overall Compliance: No
Severity Score: 21.25			
Codes/Mitigation Info/Possible Solution		Field Measurements/Component Compliance

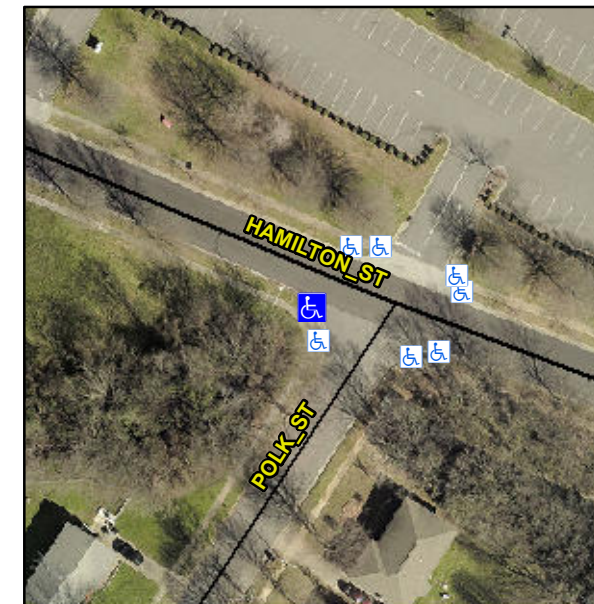
Compliance	Description	Data	Compliance	Description	Data
N/A	Ramp Length (in)	114.5	Yes	Ramp Slope (%)	5.5
No	Ramp Width (in)	47.0	No	Ramp XSlope (%)	6.3
N/A	Flare Type LT	N/A	N/A	Flare Type RT	N/A
N/A	Flare Slope LT (%)	N/A	N/A	Flare Slope RT (%)	N/A
N/A	Flare Traversable LT?	N/A	N/A	Flare Traversable RT?	N/A
N/A	Landing Length (in)	N/A	N/A	DWS Provided?	N/A
N/A	Landing Width (in)	N/A	N/A	DWS Contrast?	N/A
N/A	Landing Slope (%)	N/A	N/A	DWS Length (in)	N/A
N/A	Landing X Slope (%)	N/A	N/A	DWS Full Width?	N/A
N/A	Landing Curb? (Y/N)	N/A	N/A	DWS Offset (in)	N/A
N/A	Shared Landing?	N/A			
N/A	Gutter Ponding?	N/A	N/A	Gutter Slope (%)	N/A
N/A	Gutter Lip Ht (in)	N/A	N/A	Gutter X Slope (%)	N/A
N/A	Painted X Walk1?	No	N/A	Painted X Walk2?	N/A
	X Walk 1 Direction	To NE		X Walk 2 Direction	N/A
N/A	X Walk 1 Width (in)	N/A	N/A	X Walk 2 Width (in)	N/A
	X Walk 1 Slope (%)	6.1		X Walk 2 Slope (%)	N/A
	X Walk 1 X Slope (%)	4.3		X Walk 2 X Slope (%)	N/A

N/A	Ramp inside XWalk1?	N/A	N/A	Ramp inside XWalk2?	N/A
	Road Slope (%)	N/A	N/A	Clear Space?	N/A
	Road X Slope (%)	N/A	N/A	Clear Space to XWalk (in)	N/A
N/A	Any Obstructions?	N/A	N/A	Storm Grate/Utility Hazard?	N/A
	Obstruction Type			Storm Grate/Utility Type	
		N/A			N/A
			Yes	Surface Condition? (G/P)	Good

Possible Solutions:

Remove & Replace Entire Ramp.

Not Found, R304.5.1, R304.5.3
