# Access Compliance Report

## Public Rights-of-Way

### (Curb Ramps)

Intersection ID: 4219	Main Street: DAVIS_LAKE_PY	Cross Street: UNIVERSITY_STATION_CR	Location: SE
ADA ID: 2B8EBACCD99C	Ramp Type: Directional1	Initial Pass/Fail: Fail	Overall Compliance: No
Severity Score: 33.75			
Codes/Mitigation Info/Possible Solution		Field Measurements/Component Compliance

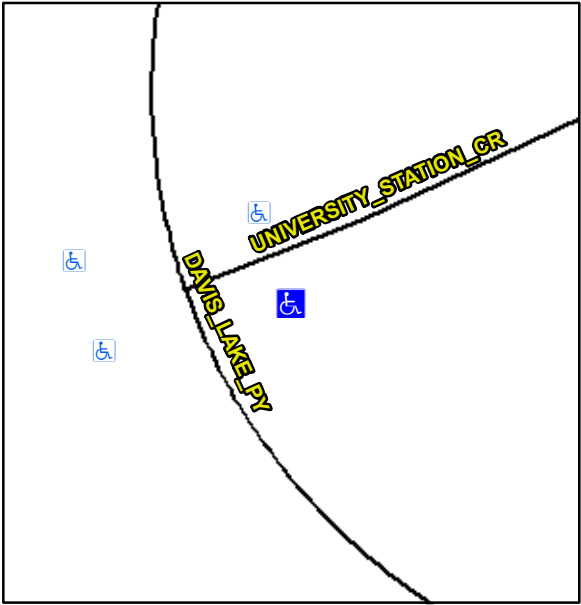
Possible Solutions:		Compliance		Description		Data	Compliance	Description	Data
	Remove & Replace Entire Ramp.		N/A		Ramp Length (in)		29.0	N/A	Grade Break?	N/A
			No		Ramp Width (in)		44.0	N/A	Grade Break Slope (%)	0.0
			No		Ramp Slope (%)		11.3	N/A	Grade Break XSlope (%)	0.0
			No		Ramp XSlope (%)		6.1			
			N/A		Flare Type LT		N/A	N/A	Flare Type RT	N/A
			N/A		Flare Slope LT (%)		N/A	N/A	Flare Slope RT (%)	0.0
			N/A		Flare Traversable LT?		N/A	N/A	Flare Traversable RT?	N/A
			N/A		Landing Length (in)		0.0	N/A	DWS Provided?	N/A
			N/A		Landing Width (in)		0.0	N/A	DWS Contrast?	N/A
			N/A		Landing Slope (%)		0.0	N/A	DWS Length (in)	N/A
			N/A		Landing X Slope (%)		0.0	N/A	DWS Full Width?	N/A
			N/A		Landing Curb? (Y/N)		N/A	N/A	DWS Offset LT (in)	N/A
			N/A		Shared Landing?		N/A	N/A	DWS Offset RT (in)	N/A
			N/A		Gutter Ponding?		0.0	N/A	Gutter Slope (%)	N/A
			N/A		Gutter Lip Ht (in)		0.0	N/A	Gutter X Slope (%)	N/A

N/A		Painted X Walk1?		No		Road Slope (%)	1.3
					X Walk 1 Direction	To NW			Road X Slope (%)	8.4
					X Walk 1 Width (in)		N/A		Clear Space?	N/A
					X Walk 1 Slope (%)		1.3	N/A	Clear Space to XWalk (in)	N/A
					X Walk 1 X Slope (%)		8.4	N/A	Storm Grate/Utility Hazard?	N/A
			N/A		Ramp inside XWalk1?		N/A		Storm Grate/Utility Type	
			N/A		Any Obstructions?		N/A			N/A
					Obstruction Type			Yes	Surface Condition? (G/P)	Good
								N/A	Curb Slope (%)	N/A
Surveyor Notes:										
N/A										
PROW/ADA:										
R304.5.1, R304.2.2, R304.5.3										
Total Cost:		\$	1600.00
