Access Compliance Report

Public Rights-of-Way

(Curb Ramps)

Intersection ID: 42785	Main Street: CALDWELL_RD	Cross Street: OLD_STONE_CROSSING_DR	Location: SE
ADA ID: 2B9CE832D62B	Ramp Type: Combination1	Initial Pass/Fail: Fail	Overall Compliance: No
Codes/Mitigation Info/Possible Solution		Field Measurements/Component Compliance	
Severity Score: 37.5

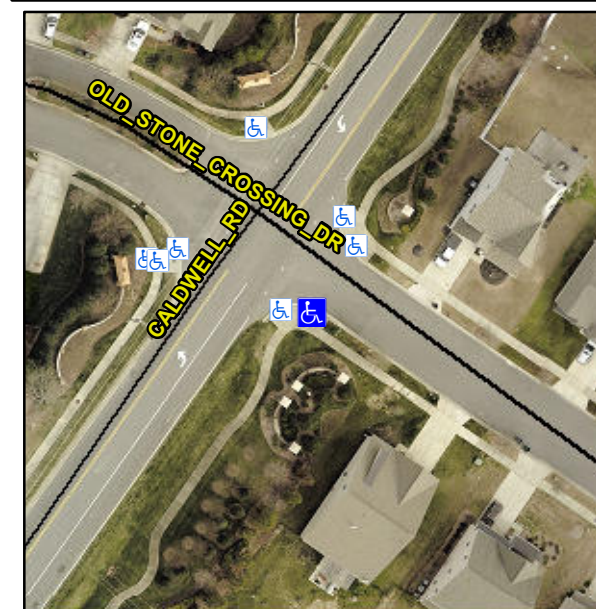
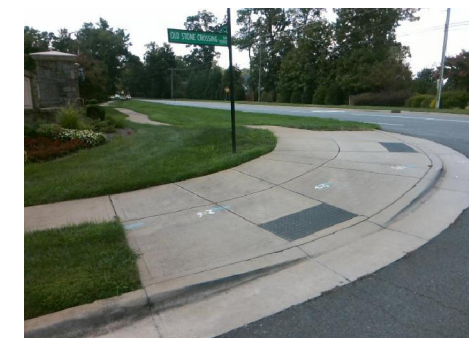
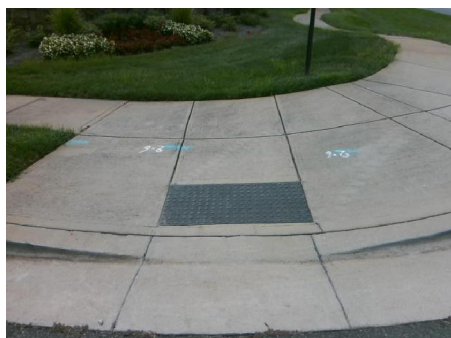
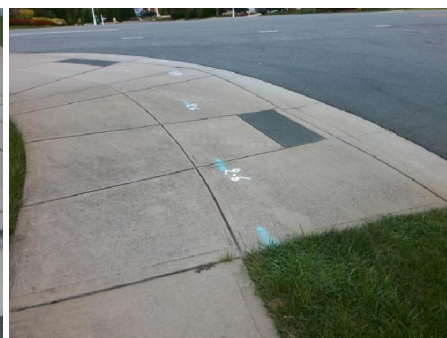
Not Found, R304.5.3, R304.3.2

Compliance	Description	Data	Compliance	Description	Data
N/A	Ramp Length LT (in)	42.5	N/A	Ramp Length RT (in)	32.0
Yes	Ramp Width LT (in)	59.0	Yes	Ramp Width RT (in)	59.5
No	Ramp Slope LT (%)	9.0	No	Ramp Slope RT (%)	15.2
No	Ramp XSlope LT (%)	2.3	Yes	Ramp XSlope RT (%)	1.5
N/A	Ramp Length (in)	71.0	Yes	Ramp Slope (%)	3.8
Yes	Ramp Width (in)	48.0	No	Ramp XSlope (%)	6.6
N/A	Flare Type LT	N/A	N/A	Flare Type RT	N/A
N/A	Flare Slope LT (%)	N/A	N/A	Flare Slope RT (%)	N/A
N/A	Flare Traversable LT?	N/A	N/A	Flare Traversable RT?	N/A
N/A	Landing Length (in)	N/A	N/A	DWS Provided?	N/A
N/A	Landing Width (in)	N/A	N/A	DWS Contrast?	N/A
N/A	Landing Slope (%)	N/A	N/A	DWS Length (in)	N/A
N/A	Landing X Slope (%)	N/A	N/A	DWS Full Width?	N/A
N/A	Landing Curb? (Y/N)	N/A	N/A	DWS Offset (in)	N/A
N/A	Shared Landing?	N/A			
N/A	Gutter Ponding?	N/A	N/A	Gutter Slope (%)	N/A
N/A	Gutter Lip Ht (in)	N/A	N/A	Gutter X Slope (%)	N/A
N/A	Painted X Walk1?	No	N/A	Painted X Walk2?	N/A

X Walk 1 Direction	To NE		X Walk 2 Direction	N/A
	X Walk 1 Width (in)	N/A		X Walk 2 Width (in)	N/A
	X Walk 1 Slope (%)	1.6		X Walk 2 Slope (%)	N/A
	X Walk 1 X Slope (%)	6.3		X Walk 2 X Slope (%)	N/A
N/A	Ramp inside XWalk1?	N/A	N/A	Ramp inside XWalk2?	N/A
	Road Slope (%)	N/A		Clear Space?	N/A
	Road X Slope (%)	N/A	N/A	Clear Space to XWalk (in)	N/A
			N/A	Any Obstruction?	N/A
				Obstruction Type	N/A
			N/A	Storm Grate/Utility Hazard?	N/A
				Storm Grate/Utility Type	N/A
Yes	Surface Condition? (G/P)	Good			
	Curb Slope (%)	15.2

Possible Solutions:

Remove & Replace Entire Ramp.
