Access Compliance Report

Public Rights-of-Way

(Curb Ramps)

| Intersection ID: 52226 | Main Street: AMESBURY_HILL_DR | Cross Street: AUBURN_HILL_LN | Location: SE |

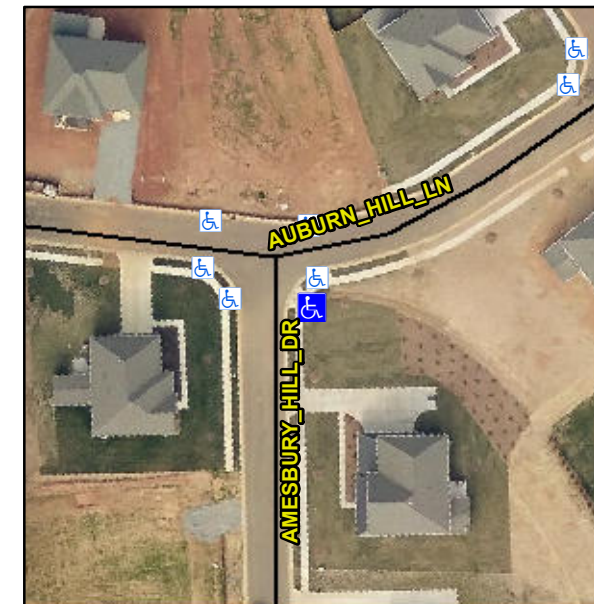
| ADA ID: 2BA5F3E9C0C3 | Ramp Type: Perp | Initial Pass/Fail: Fail | Overall Compliance: No |
| | | Severity Score: 10 | |

Not Found, R304.5.1, R304.5.3

| Compliance | Description | Data | Compliance | Description | Data |
|---|---|---|---|---|---|
| No | Ramp Width (in) | 44.0 | No | Ramp XSlope (%) | 4.5 |

Possible Solutions:

Remove & Replace Entire Ramp.

Total Cost: \$ 1850.00
