# Access Compliance Report

## Public Rights-of-Way (Curb Ramps)

Intersection ID: 30536	Main Street: S_TRYON_ST	Cross Street: BENNINGTON_PLACE_DR	Location: NW
ADA ID: 2BB7CD0AD1A5	Ramp Type: PerpDiag	Initial Pass/Fail: Fail	Overall Compliance: No
Severity Score: 21.25			
Codes/Mitigation Info/Possible Solution		Field Measurements/Component Compliance

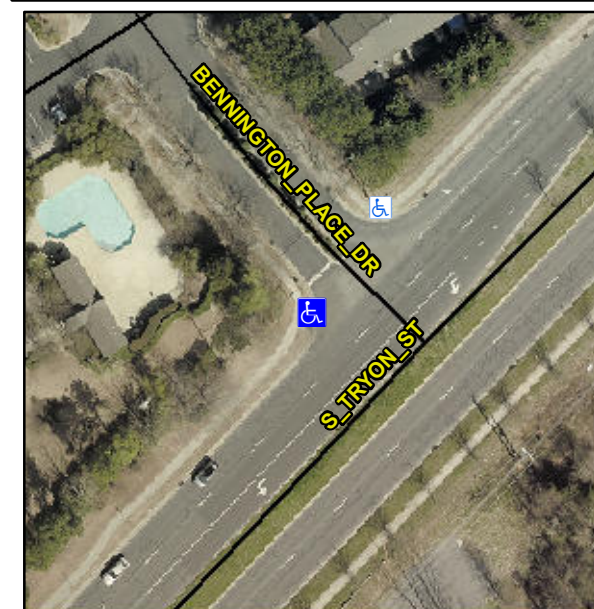
**Not Found, R304.5.1, R304.2.2**

Compliance	Description	Data	Compliance	Description	Data
N/A	Ramp Length (in)	80.0	No	Ramp Slope (%)	10.5
No	Ramp Width (in)	47.0	Yes	Ramp XSlope (%)	0.7
N/A	Flare Type LT	N/A	N/A	Flare Type RT	N/A
N/A	Flare Slope LT (%)	N/A	N/A	Flare Slope RT (%)	N/A
N/A	Flare Traversable LT?	N/A	N/A	Flare Traversable RT?	N/A
N/A	Landing Length (in)	N/A	N/A	DWS Provided?	N/A
N/A	Landing Width (in)	N/A	N/A	DWS Contrast?	N/A
N/A	Landing Slope (%)	N/A	N/A	DWS Length (in)	N/A
N/A	Landing X Slope (%)	N/A	N/A	DWS Full Width?	N/A
N/A	Landing Curb? (Y/N)	N/A	N/A	DWS Offset (in)	N/A
N/A	Shared Landing?	N/A			
N/A	Gutter Ponding?	N/A	N/A	Gutter Slope (%)	N/A
N/A	Gutter Lip Ht (in)	1.5	N/A	Gutter X Slope (%)	N/A
N/A	Painted X Walk1?	No	N/A	Painted X Walk2?	No
	X Walk 1 Direction	To SE		X Walk 2 Direction	To NE
N/A	X Walk 1 Width (in)	N/A	N/A	X Walk 2 Width (in)	N/A
	X Walk 1 Slope (%)	1.8		X Walk 2 Slope (%)	0.9
	X Walk 1 X Slope (%)	0.8		X Walk 2 X Slope (%)	0.3

N/A	Ramp inside XWalk1?	N/A	N/A	Ramp inside XWalk2?	N/A
	Road Slope (%)	1.6	N/A	Clear Space?	N/A
	Road X Slope (%)	0.7	N/A	Clear Space to XWalk (in)	N/A
N/A	Any Obstructions?	N/A	N/A	Storm Grate/Utility Hazard?	N/A
	Obstruction Type			Storm Grate/Utility Type	
		N/A			N/A
		Yes		Surface Condition? (G/P)	Good

**Remove & Replace Curb Ramp With Two New Directional Ramps or Equivalent.**
