# Access Compliance Report

## Public Rights-of-Way (Curb Ramps)

| Intersection ID: 12159 | Main Street: W_MOREHEAD_ST | Cross Street: MCNINCH_ST | Location: SE |
| ADA ID: 2BB837583F33 | Ramp Type: Directional1 | Initial Pass/Fail: Fail | Overall Compliance: No |

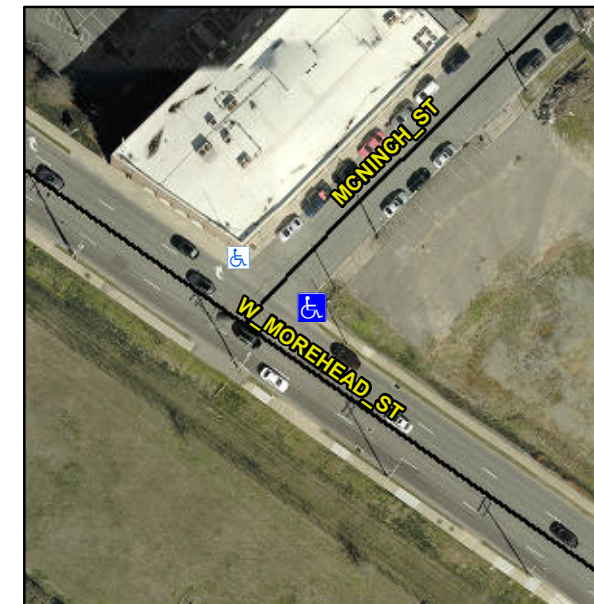
| | | Severity Score: 65 | |

**R304.2.2, R304.5.3, R302.7**

| Compliance | Description | Data | Compliance | Description | Data |
|---|---|---|---|---|---|
| No | Ramp Slope (%) | 12.0 | N/A | Grade Break XSlope (%) | 0.0 |
| No | Ramp XSlope (%) | 7.0 | | | |
| | Obstruction Type | | No | Surface Condition? (G/P) | Poor |

**Remove & Replace Entire Ramp.**

Total Cost: \$ 1600.00
