Access Compliance Report

Public Rights-of-Way

(Curb Ramps)

Intersection ID: 14679	Main Street: MCMANUS_DR	Cross Street: WINTERFIELD_PL	Location: NW
ADA ID: 2BBDC8587E2C	Ramp Type: Perp	Initial Pass/Fail: Fail	Overall Compliance: No
			Severity Score: 21.25

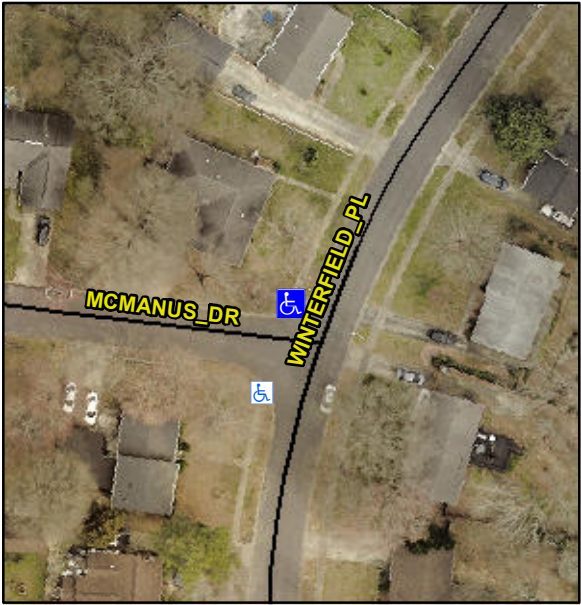
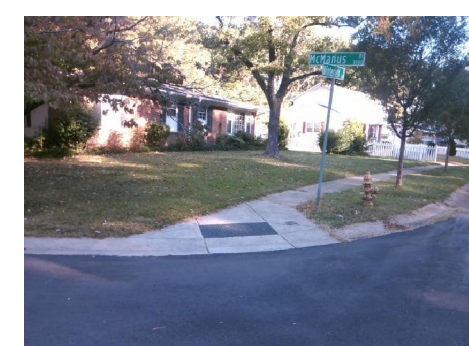
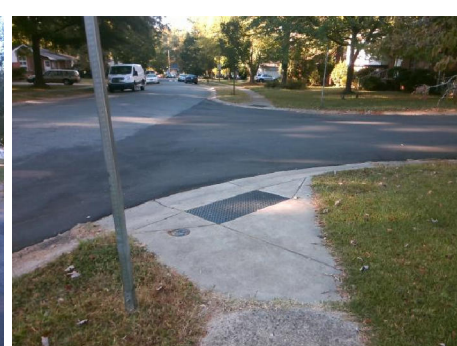
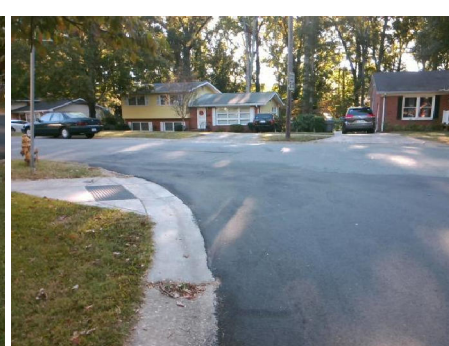
Possible Solutions:		Compliance	Description	Data
	Remove & Replace Entire Ramp.		No	Ramp Length (in)	40.0
			No	Ramp Width (in)	47.0
			N/A	Flare Type LT	N/A
			N/A	Flare Slope LT (%)	N/A
			N/A	Flare Traversable LT?	N/A
			N/A	Landing Length (in)	N/A
			N/A	Landing Width (in)	N/A
			N/A	Landing Slope (%)	N/A
			N/A	Landing X Slope (%)	N/A
<p>Surveyor Notes:</p> <p>N/A</p> <p>PROW/ADA:</p> <p>Not Found, R304.5.1, R304.2.2</p>			N/A	Flare Type RT	N/A
			N/A	Flare Slope RT (%)	N/A
			N/A	Flare Traversable RT?	N/A
			N/A	DWS Provided?	N/A
			N/A	DWS Contrast?	N/A
			N/A	DWS Length (in)	N/A
			N/A	DWS Full Width?	N/A
			N/A	DWS Offset (in)	N/A
			N/A	Gutter Ponding?	N/A
			N/A	Gutter Lip Ht (in)	N/A
			No	Painted X Walk1?	N/A
			To S	X Walk 1 Direction	N/A
			N/A	X Walk 1 Width (in)	N/A

1.1	X Walk 1 Slope (%)	N/A
			4.0	X Walk 1 X Slope (%)	N/A
			N/A	Ramp inside XWalk1?	N/A
			N/A	Road Slope (%)	N/A
			N/A	Road X Slope (%)	N/A
			N/A	Any Obstructions?	N/A
				Obstruction Type	N/A
Total Cost:			\$	1850.00	
			N/A		N/A
			Yes	Surface Condition? (G/P)	Good
