Access Compliance Report

Public Rights-of-Way

(Curb Ramps)

Intersection ID: 46814	Main Street: OLDE_IVY_WY	Cross Street: RED_BIRCH_DR	Location: S
ADA ID: 2BDFF133E91C	Ramp Type: PerpDiag	Initial Pass/Fail: Fail	Overall Compliance: No
Severity Score: 22.5			
Codes/Mitigation Info/Possible Solution		Field Measurements/Component Compliance

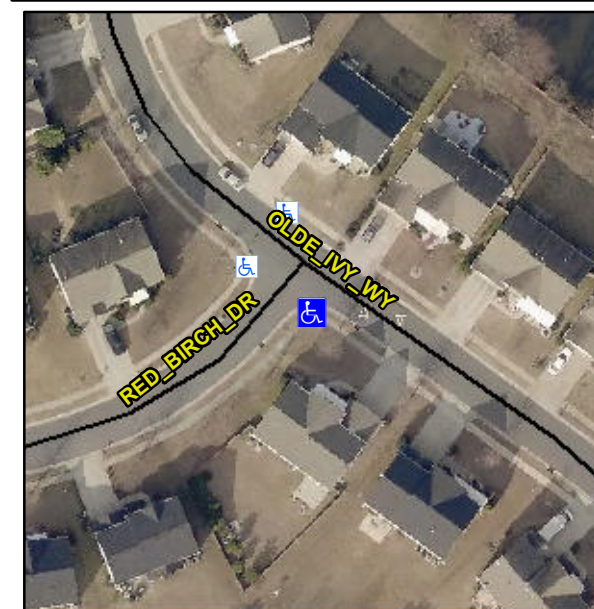
R304.5.1, R304.2.2, R304.5.3

Compliance	Description	Data	Compliance	Description	Data
N/A	Ramp Length (in)	46.0	No	Ramp Slope (%)	9.1
No	Ramp Width (in)	39.0	No	Ramp XSlope (%)	3.1
N/A	Flare Type LT	N/A	N/A	Flare Type RT	N/A
N/A	Flare Slope LT (%)	N/A	N/A	Flare Slope RT (%)	N/A
N/A	Flare Traversable LT?	N/A	N/A	Flare Traversable RT?	N/A
N/A	Landing Length (in)	N/A	N/A	DWS Provided?	N/A
N/A	Landing Width (in)	N/A	N/A	DWS Contrast?	N/A
N/A	Landing Slope (%)	N/A	N/A	DWS Length (in)	N/A
N/A	Landing X Slope (%)	N/A	N/A	DWS Full Width?	N/A
N/A	Landing Curb? (Y/N)	N/A	N/A	DWS Offset (in)	N/A
N/A	Shared Landing?	N/A			
N/A	Gutter Ponding?	N/A	N/A	Gutter Slope (%)	N/A
N/A	Gutter Lip Ht (in)	N/A	N/A	Gutter X Slope (%)	N/A
N/A	Painted X Walk1?	No	N/A	Painted X Walk2?	No
	X Walk 1 Direction	To NW		X Walk 2 Direction	To NE
N/A	X Walk 1 Width (in)	N/A	N/A	X Walk 2 Width (in)	N/A
	X Walk 1 Slope (%)	2.1		X Walk 2 Slope (%)	4.3
	X Walk 1 X Slope (%)	3.9		X Walk 2 X Slope (%)	0.4

N/A	Ramp inside XWalk1?	N/A	N/A	Ramp inside XWalk2?	N/A
	Road Slope (%)	1.5	N/A	Clear Space?	N/A
	Road X Slope (%)	4.4	N/A	Clear Space to XWalk (in)	N/A
N/A	Any Obstructions?	N/A	N/A	Storm Grate/Utility Hazard?	N/A
	Obstruction Type			Storm Grate/Utility Type	
		N/A			N/A
			Yes	Surface Condition? (G/P)	Good

Remove & Replace Curb Ramp With Two New Directional Ramps or Equivalent.
