Access Compliance Report Public Rights-of-Way (Curb Ramps)

Intersection ID: 48944 Main Street: LILLYSHIRE PL Cross Street: CALDWELL RIDGE PY Location: SW **Severity Score:** 10 ADA ID: 2BE1CDEA5592 Ramp Type: Combination1 Initial Pass/Fail: Fail **Overall Compliance: No**

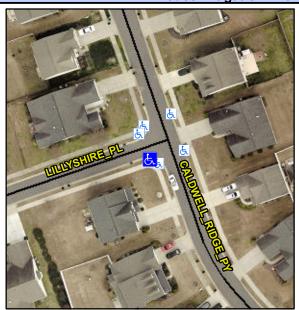
Street 1 Name StopSign Stop Condition-Street 1 LILLYSHIRE PL N/A Street 2 Name Stop Condition-Street 2 N/A Possible Solutions: Compliance Description N/A Remove & Replace Entire Ramp. Yes Yes No No Surveyor Notes: LT RP < 5% PROW/ADA: Not Found, R304.5.1, R304.5.3
