Access Compliance Report

Public Rights-of-Way

(Curb Ramps)

Intersection ID: 31447	Main Street: RIDING_HILL_AV	Cross Street: GLENLUCE_AV	Location: SE
ADA ID: 2C0690CBCC7F	Ramp Type: PerpDiag	Initial Pass/Fail: Fail	Overall Compliance: No
		Severity Score: 10

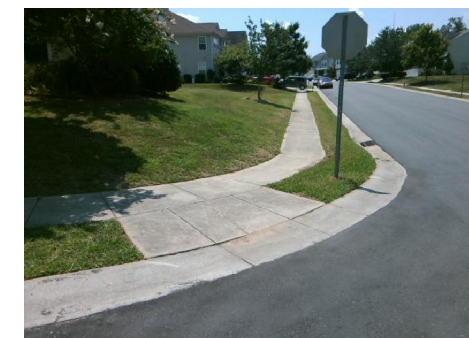
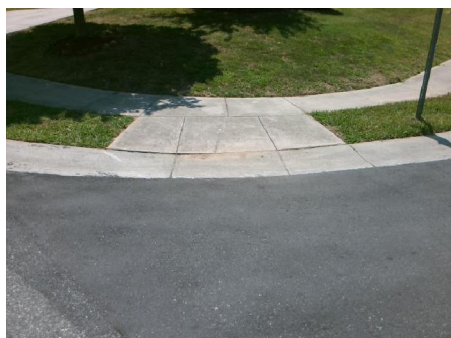
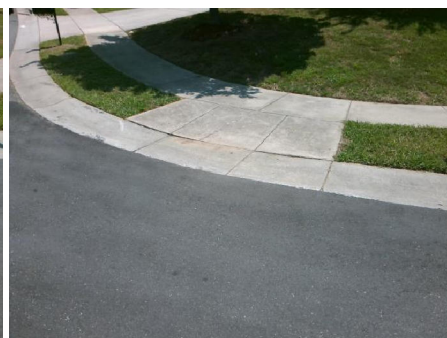
Not Found, R304.5.1, R304.5.3

Compliance	Description	Data	Compliance	Description	Data
N/A	Ramp Length (in)	48.0	Yes	Ramp Slope (%)	8.3
No	Ramp Width (in)	43.0	No	Ramp XSlope (%)	2.3
N/A	Flare Type LT	N/A	N/A	Flare Type RT	N/A
N/A	Flare Slope LT (%)	N/A	N/A	Flare Slope RT (%)	N/A
N/A	Flare Traversable LT?	N/A	N/A	Flare Traversable RT?	N/A
N/A	Landing Length (in)	N/A	N/A	DWS Provided?	N/A
N/A	Landing Width (in)	N/A	N/A	DWS Contrast?	N/A
N/A	Landing Slope (%)	N/A	N/A	DWS Length (in)	N/A
N/A	Landing X Slope (%)	N/A	N/A	DWS Full Width?	N/A
N/A	Landing Curb? (Y/N)	N/A	N/A	DWS Offset (in)	N/A
N/A	Shared Landing?	N/A			
N/A	Gutter Ponding?	N/A	N/A	Gutter Slope (%)	N/A
N/A	Gutter Lip Ht (in)	N/A	N/A	Gutter X Slope (%)	N/A
N/A	Painted X Walk1?	No	N/A	Painted X Walk2?	No
	X Walk 1 Direction	To N		X Walk 2 Direction	To W
N/A	X Walk 1 Width (in)	N/A	N/A	X Walk 2 Width (in)	N/A
	X Walk 1 Slope (%)	1.6		X Walk 2 Slope (%)	6.7
	X Walk 1 X Slope (%)	5.3		X Walk 2 X Slope (%)	0.9

N/A	Ramp inside XWalk1?	N/A	N/A	Ramp inside XWalk2?	N/A
	Road Slope (%)	2.8	N/A	Clear Space?	N/A
	Road X Slope (%)	1.4	N/A	Clear Space to XWalk (in)	N/A
N/A	Any Obstructions?	N/A	N/A	Storm Grate/Utility Hazard?	N/A
	Obstruction Type			Storm Grate/Utility Type	
		N/A			N/A
			Yes	Surface Condition? (G/P)	Good

Remove & Replace Curb Ramp With Two New Directional Ramps or Equivalent.
