# Access Compliance Report

## Public Rights-of-Way

### (Curb Ramps)

| Intersection ID: 7277 | Main Street: NORTHRIDGE_VILLAGE_DR | Cross Street: TOM_HUNTER_RD | Location: NW |

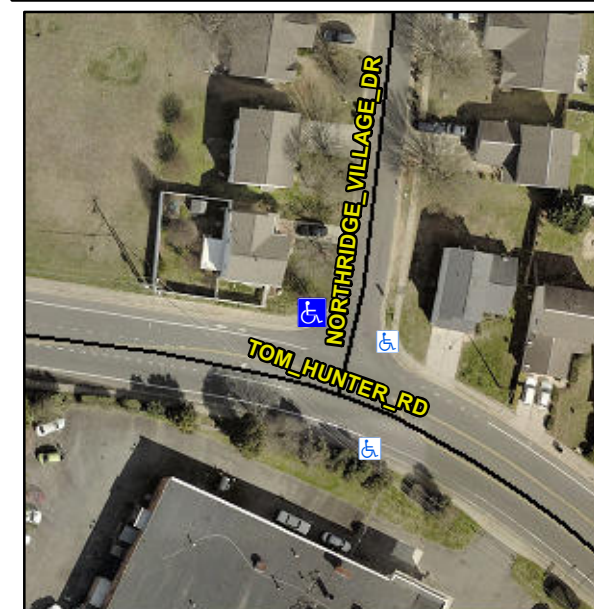
Surveyor Notes:

**NO RT SW, LT RP < 5%; CURB GAP 1.5**

| Compliance | Description | Data | Compliance | Description | Data |
|---|---|---|---|---|---|
| No | Ramp XSlope LT (%) | 5.8 | No | Ramp XSlope RT (%) | 5.5 |

Possible Solutions:

**Remove & Replace Entire Ramp.**
