# Access Compliance Report

## Public Rights-of-Way

### (Curb Ramps)

Intersection ID: N/A	Main Street: PROVIDENCE_RD	Cross Street: N/A	Location: S
ADA ID: 2C0A19209591	Ramp Type: Perp	Initial Pass/Fail: Fail	Overall Compliance: No
Severity Score: 10			
Codes/Mitigation Info/Possible Solution		Field Measurements/Component Compliance

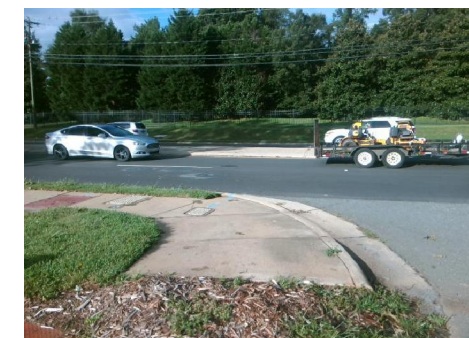
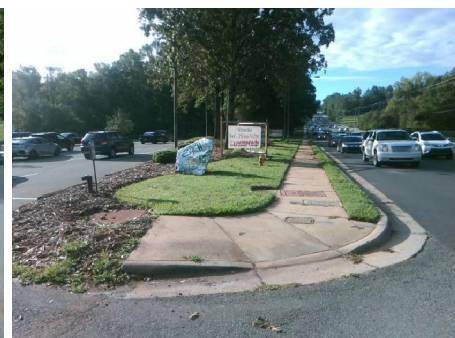
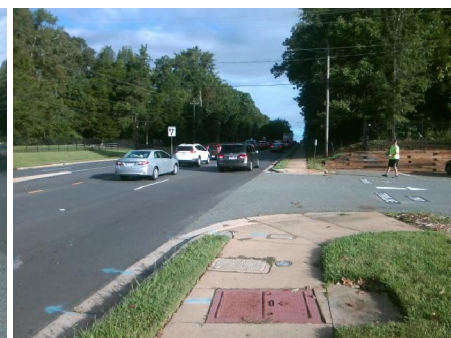
**Not Found, R304.5.1, R304.5.3**

Compliance	Description	Data	Compliance	Description	Data
N/A	Ramp Length (in)	83.0	Yes	Ramp Slope (%)	7.3
No	Ramp Width (in)	47.0	No	Ramp XSlope (%)	2.9
N/A	Flare Type LT	N/A	N/A	Flare Type RT	N/A
N/A	Flare Slope LT (%)	N/A	N/A	Flare Slope RT (%)	N/A
N/A	Flare Traversable LT?	N/A	N/A	Flare Traversable RT?	N/A
N/A	Landing Length (in)	N/A	N/A	DWS Provided?	N/A
N/A	Landing Width (in)	N/A	N/A	DWS Contrast?	N/A
N/A	Landing Slope (%)	N/A	N/A	DWS Length (in)	N/A
N/A	Landing X Slope (%)	N/A	N/A	DWS Full Width?	N/A
N/A	Landing Curb? (Y/N)	N/A	N/A	DWS Offset (in)	N/A
N/A	Shared Landing?	N/A			
N/A	Gutter Ponding?	N/A	N/A	Gutter Slope (%)	N/A
N/A	Gutter Lip Ht (in)	N/A	N/A	Gutter X Slope (%)	N/A
N/A	Painted X Walk1?	No	N/A	Painted X Walk2?	N/A
	X Walk 1 Direction	To NW		X Walk 2 Direction	N/A
N/A	X Walk 1 Width (in)	N/A	N/A	X Walk 2 Width (in)	N/A
	X Walk 1 Slope (%)	3.7		X Walk 2 Slope (%)	N/A
	X Walk 1 X Slope (%)	1.6		X Walk 2 X Slope (%)	N/A

N/A	Ramp inside XWalk1?	N/A	N/A	Ramp inside XWalk2?	N/A
	Road Slope (%)	N/A	N/A	Clear Space?	N/A
	Road X Slope (%)	N/A	N/A	Clear Space to XWalk (in)	N/A
N/A	Any Obstructions?	N/A	N/A	Storm Grate/Utility Hazard?	N/A
	Obstruction Type			Storm Grate/Utility Type	
		N/A			N/A
			Yes	Surface Condition? (G/P)	Good

**Remove & Replace Entire Ramp.**
